Influence of deformation due to collision on mechanical behavior of steel bridge

E. Yamaguchi, T. Amamoto & D. Nakashima
Kyushu Institute of Technology, Kitakyushu 804-8550, Japan

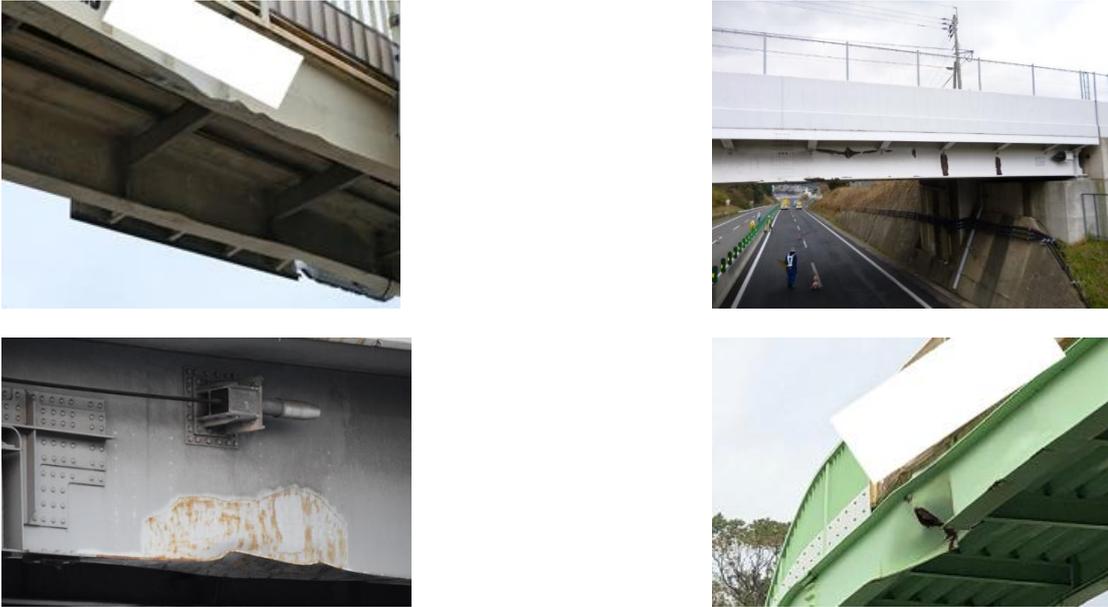
From time to time, an overpass bridge damaged apparently by the collision of a truck is found. Some of those bridges are presented in Figure 1. They are all in the region where the authors' institute is located.

Figure 1. Bridges damaged by collision.

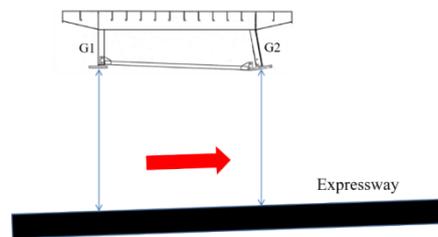
Figure 3. Schematic of deformation.

Only one of the main girders, G2, was found damaged. This is because the expressway below the bridge is uphill. The lower flange and the web were displaced outward, as is shown schematically in Figure 3. The cross girders set in the upper part of the web restricted the web deformation only to the lower part. The residual horizontal displacements of the lower flange of G2 were measured, the results of which are presented in Figure 4.

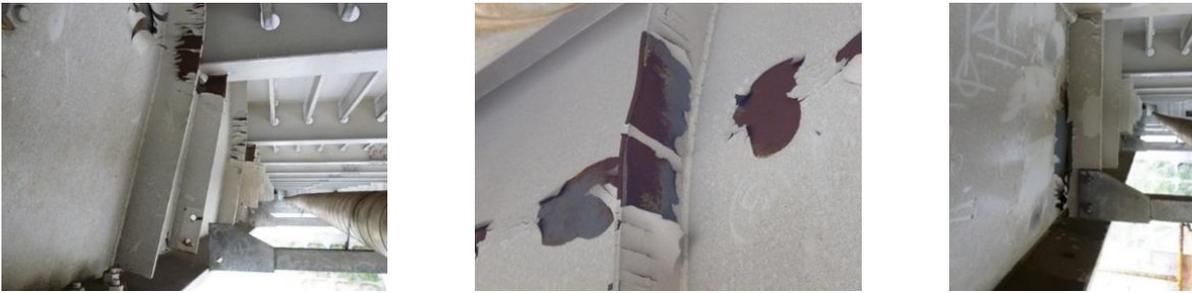
(a) (b) (c)
 Figure 5. Damages due to collision (a) Bent transverse-stiffeners and strut separated from stiffener (b) Buckled transverse-stiffener (c) Transverse stiffener separated from web.

The deformation of the main-girder web and the lower flange are not the only damage. In addition to them, some transverse stiffeners were bent and/or buckled; some welded connections between the transverse stiffeners and the web were fractured, separating the transverse stiffeners from the web; and some bolted connections between the transverse stiffeners and the lateral struts were broken, separating the lateral struts from the transverse stiffeners. Those damages are can be observed in Figure 5.

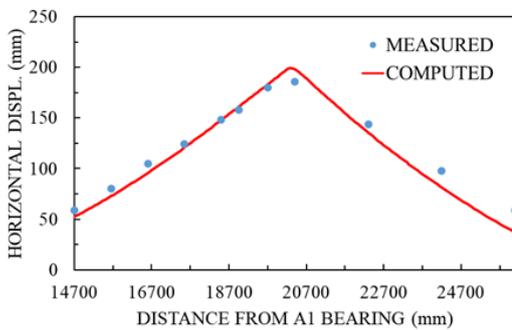
The computed residual horizontal displacement of the lower flange is plotted together with the measured displacement in Figure 8. Fairly good agreement is observed. The collision load 1587 N/mm is distributed over 540 mm, the total of which amounts to 857 kN. This value is comparable to the design collision load of 1000 kN. These observations validate the present analysis.

Figure 8. Residual horizontal displacement of lower flange.

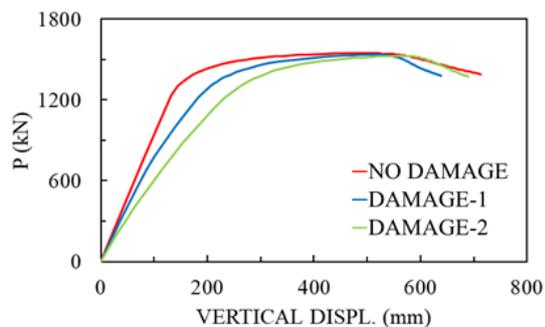
Figure 11. Load P - vertical displacement relationship at Point C.

The numerical result in terms of the load P and the vertical displacement at Point C is presented in Figure 11. The mechanical behavior of the girder damaged by the collision is given as DAMAGE-1, while that of the intact girder is as NO DAMAGE. The results indicate that the initial stiffness is reduced by 14%. Unlike the case of Nakayama et al. (2008), the maximum load doesn't increase. It decreases instead, yet the reduction is merely 0.8%, from 1548 kN to 1536 kN.

To further investigate the influence of the damage, the residual horizontal displacement is increased by a factor of 1.5: the maximum horizontal displacement is then 1/104 of the span length. The same analysis as above is conducted and the result is shown as DAMAGE-2 in Figure 11. The reduction in the initial stiffness now becomes 31%. Yet the reduction in the maximum load is still rather small, which is only 1.3%, from 1548 kN to 1528 kN.

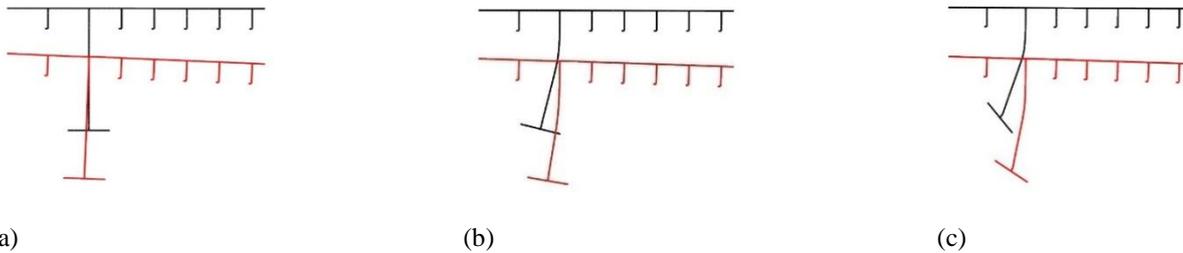
Figure 12. Deformed configuration of girder (a) no damage (b) damage-1 (c) damage-2.

The deformation of the girder is given in Figure 12. The black figure is the cross section before loading. The red figure is the deformed configuration at the maximum load. The vertical displacement is dominant in case of the intact girder as it should. On the other hand, the horizontal displacement is also significant in the damaged girders: they tend to deform in the way that reduces the horizontal residual displacement. The damage due to collision thus changes the deformation characteristic of the girder considerably.
