## Saga of hundred years of Hardinge bridge

A. Ghoshal

*STUP Consultants Pvt. Ltd., India*

**ABSTRACT:** The Hardinge Bridge across River Padma is a remarkable achievement in Civil Engineering. This bridge is 5328 ft. long, one of the longest in its time, has 15 spans of 345 ft 1½ in. apart from three land spans of 75 ft. on either end. 345 ft. span for double line Broad Gauge traffic was itself a record holder at its time and even today is exceeded by few others in the subcontinent. The Bridge, built with extreme caution against any breach by the turbulent flows of the river in those days, met with a serious threat on its existence during the late floods on 25th September, 1933, when a breach of 400 ft occurred in the right guide bank, that eventually extended to 1600ft on 7th October, despite day and night work by engineers and workmen, whose services were requisitioned as an emergency measure. Rehabilitation work required 2 years of intense activity. The bridge again suffered multiple crippling damages during the war of liberation in December 1971: the ninth span from Bheramara side had a direct missile hit that blew off 60 ft of the steel span, leaving it listing dangerously

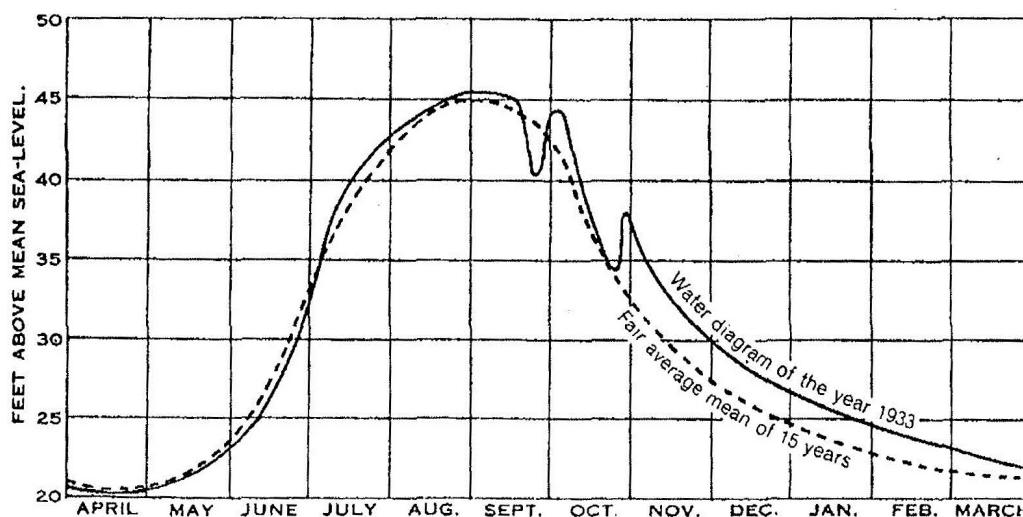
The behaviour of the river was normal during the rise of the year 1933, but, unfortunately, it was not normal during the fall. Figure 3 shows the average hydrograph of the river as well as the diagram for the year 1933; this brings out the fact that the main fall normally commences early in October. In 1933, however, the main fall appeared to commence early in September; this was attributed to the failure of the monsoon, in Northern India. Fig. 2 also shows, however, that something abnormal occurred in the middle of September, for after falling a matter of 5.20 feet, the river started a late rise with great rapidity in the third week of September. The reason for this was the fact that there was, after the failure of the monsoon, a deluge of rain, lasting several days and causing severe floods, in areas surrounding Delhi in Northern India, and this flood water found its way into the upper reaches of the Padma. The result was an abnormal rise at the end of September, creating conditions at the bridge which were without parallel or precedent. Heavy rain in Northern India frequently occurs, but there was no reason to suspect that this particular rise would come down a distance of 1,000 miles and still retain a force which, in the light of subsequent events, proved to be the cause of the destruction of the right guide bank of the Harding bridge.

Figure 3. Hydrograph of river in the year 1933

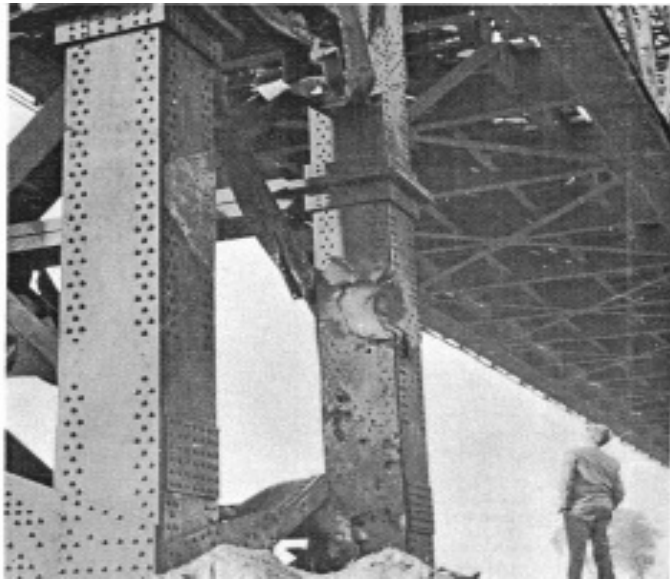
The steel supporting trestle common to spans 1 and 2 was damaged by an artillery shell attack. Steel plates of both the upstream column of the trestle were wrenched off the inner core of concrete and the bracings on two faces of the trestle were blown off. The span 15, the last span on the Paksey end suffered damage to the bottom chord of the penultimate panel, one deck panel, and the fixed bearing. Both the above damages looked repairable within reasonable time.

Figure 4. Damage to Pier

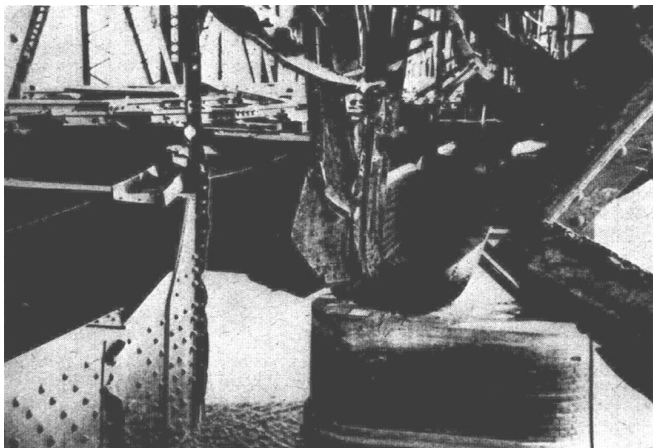
Figure 5. Damage to Span 9

Span No.9 from the Bheramara end suffered an unusual damage due to the missile attack that blew off 60 feet length of the bottom chord of the downstream truss alongwith the web members in the central region of the same truss. The severity of the blast completely damaged the deck system in the central panel. Readings taken after a month of the damage showed that the downstream truss had sagged by 4 ½ inches, while the upstream truss had sagged by only one inch. The span had also tilted out of vertical at the center towards the downstream side, by a slope of 1:250. The truss appeared unstable and looked vulnerable, to collapse, even though it sat solidly in position.

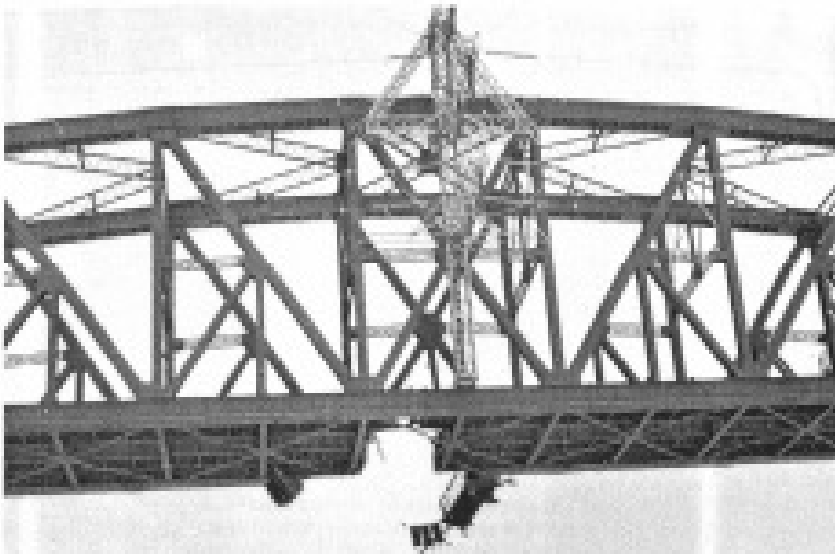
Figure 6. Damage to Span 9

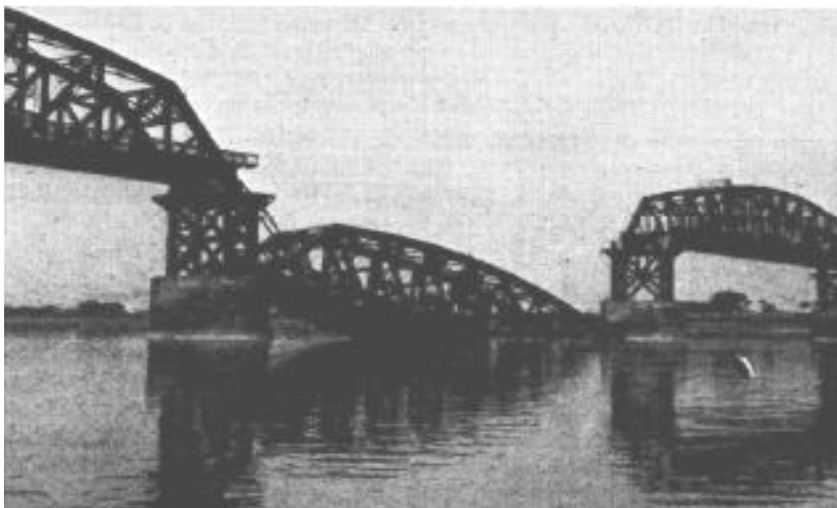
However, the most serious damage happened to span no.12 from Bheramara end, which was cut into two, due to accidental deterioration of explosive charges on all chords and webs on the second panel at end of the span. This resulted in one end of the span dropping nose down into the river, while the other end perched precariously on top of the pier, after slipping down from the bearings on top of the trestle. Members of the truss system, visible in the portion projecting above the water, appeared deformed beyond repair.

Figure 7. Fallen Span 12

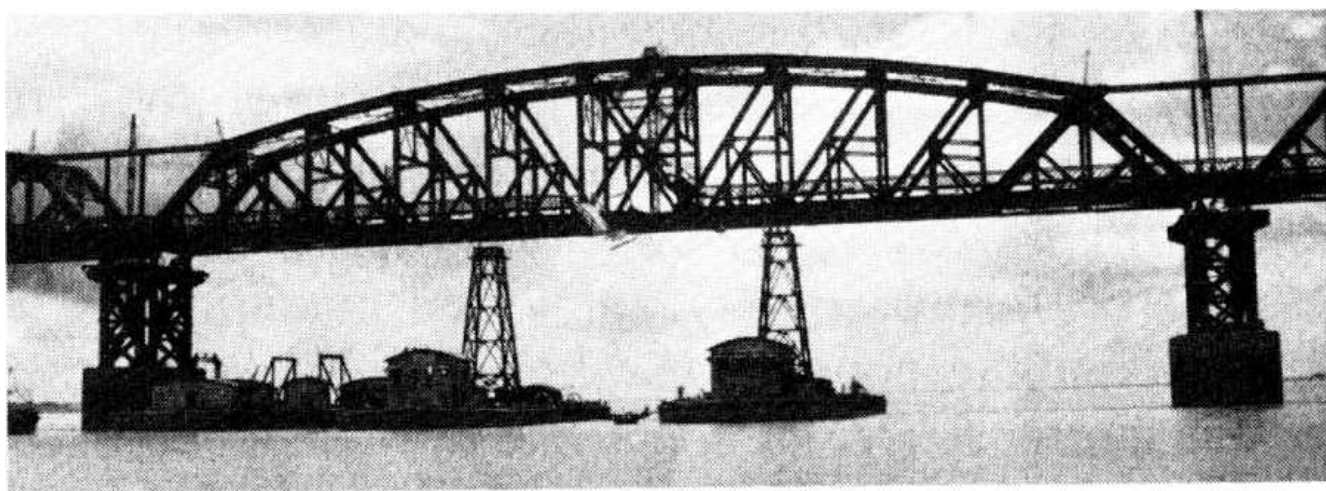
Figure 8. Repair of Span 9

As normal jacking operation was found to be impossible from the barge, it was decided to use hydraulic flotation principle for application of load on to the girder. Prior to start of jacking operations, space between the top of grillage on the top of the trestles and underside of the span was jammed with steel back plates. Inner chambers of the barges were filled with water. The compartments created inside the barges allowed systematic synchronized pumping of water from inside, with the help of electrically operated centrifugal pumps each placed close to the manholes of the six compartments of the barge. Water was pumped out of the two barges simultaneously. Pumping was alternatively carried out on the outer chambers and the central chambers to ensure uniform pressure distribution under the barge and to develop minimum moment on the barge section. As the water was being pumped out, an equivalent jacking load was transferred onto the bottom chords of the span, lifting the span back to its original position.

The raker joints at both end of the span were carefully opened out for introduction of specially designed link plates with pin holes. Similarly at ends of span 8 and 10 link plates were connected. Specially fabricated link members were introduced between spans 8 and 9 and span 9 and 10 for providing connectivity with adjacent spans. Buffer blocks were introduced between ends of bottom chord. The first phase jacking operation was carried out in the month of June when the river was already rising. This unique operation which was carried out for the first time ever, was fraught with suspense, uncertainty and tension for all the technocrats involved in the operation. However, the spans responded amazingly well and with the jacking operation the span came back to its original shape. After the jacking operation the upstream girder recovered camber and downstream girder became level. This was considered appropriate and as per theoretical estimate. All members of the span, it was proved, were indeed working within the elastic limit. Once the spans were connected with adjacent spans, the operation of replacing damaged members was taken up. Despite unfavourable weather condition and lack of proper illumination, all members were carefully removed and all missing members were replaced. Final closing was planned in middle of July, when the river level was rising furiously. The height of the trestles had to be systematically truncated to match the rise in level of river water.

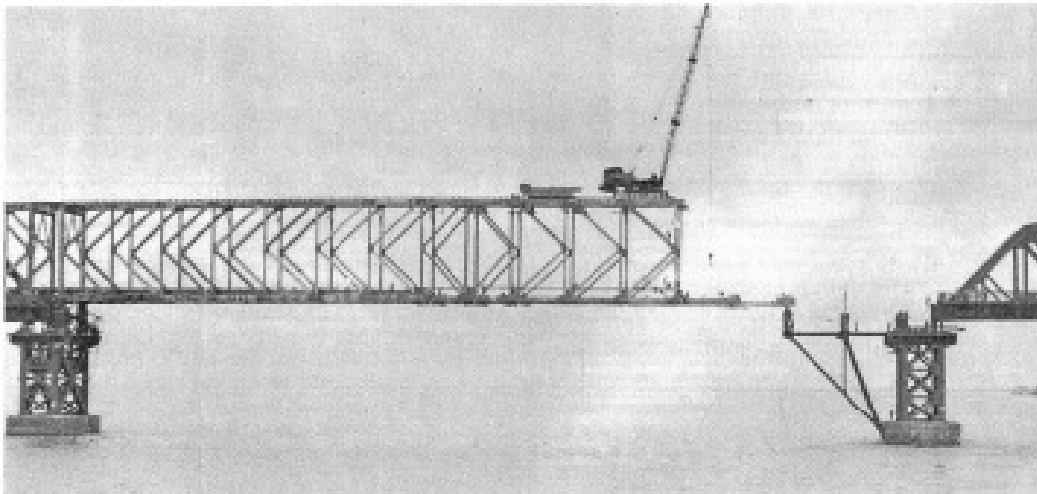
Figure 9. Temporary Linking

For doing temporary linkage, 300-foot-long spans, fabricated by BBJ for a bridge still under construction across the Godavari river in India, some 930 miles away from the Hardinge Bridge site, were utilized. These high-tensile steel-truss girders are designed for single-line broad-gauge (5½-foot) railway traffic and two lanes of roadway running on the top concrete slab deck of the span. It was found that the Godavari girders, without the concrete deck and the roadway live loading, would be capable of withstanding the 45-foot increase in span necessary for bridging the 345-foot gap at Hardinge Bridge. Two additional panels totaling 45 feet were fabricated, and one 300-foot span from Godavari was directed to the Hardinge Bridge site to make up the necessary 345-foot span. To facilitate the cantilever erection of this modified span, another 300-foot span was brought from Godavari and erected inside the 55-foot high, 32-foot wide petit truss span (11th span) for use as an anchor span.

The temporary span was lowered by 5 feet 8 inches, and the upstream track was slewed at either end to shift the railway track to the center, since the modified span was located along the center line of the bridge. This was done to facilitate the second-stage construction when a new span, identical in appearance to the existing ones, will be created – keeping the railway traffic uninterrupted during the entire erection process.

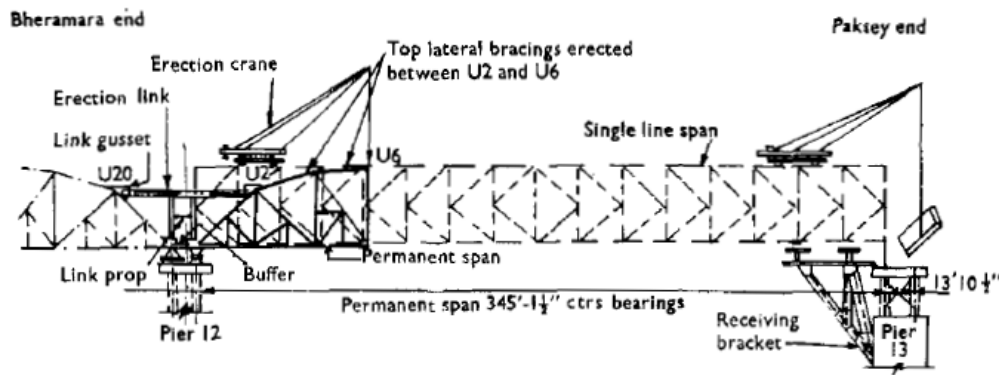
Figure 10. Erection in progress

The problems of erection of the new span was very much aggravated as the twelfth span crosses the deepest channel of the river with velocity in the region of 14 ft./Sec., during high water season. The existing girders used 1250 M/T of fabricated Mild-Steel in each span with maximum permissible stress of 18000 lb/sq.m. The weight was too large to permit convenient erection of one single new span and economy in weight of steelwork was considered essential by use of improved graders of steel currently available. Use of high tensile steel (u.t.s. 35T/m<sup>2</sup>) together with readily available mild-steel (u.t.s. 28T/m<sup>2</sup>) was planned to achieve optimum balance between weight and cost of the steelwork. The aesthetic considerations required that the underside of the bottom chord be maintained at same level as the existing spans and the depth of the cross-girders had therefore to be left unaltered. The entire deck system was designed in mild-steel constructions. The bracings in various planes and the sub-members of the main truss were also designed in mild-steel.

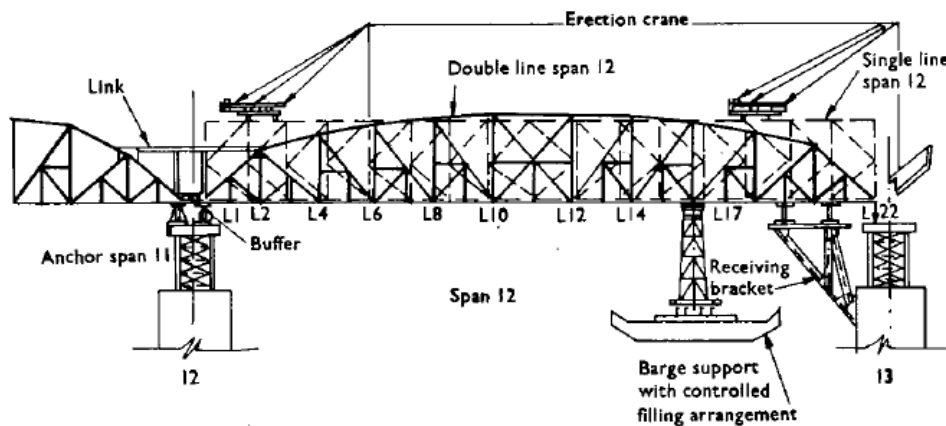
Figure 11. Erection completed
