Experimental investigation on dynamic characteristics of Meghna bridge at different structural conditions

ABSTRACT: Meghna Bridge is a pre-stressed concrete box girder balanced cantilever bridge with 87 meter long spans, each with a central hinge at cantilever portion. Significant vibrations were induced by vehicles passing over the non-functioning expansion joints at central hinges caused by severe traffic loading and lack of maintenance. Emergency repairing works were done to overcome the problem. This paper describes an experimental investigation on dynamic characteristics of the bridge with different structural conditions. Vibration measurements were carried out using tri-axial sensors on bridge deck before and after temporary repairing works. Due to nonexistence of synchronization device, cross-correlation technique was applied to reduce time lags in the vibration data recorded with different measurement devices. The Eigensystem Realization Algorithm was used to analyze the vibration records. Effects of repairing on modal properties of the bridge are discussed. Additionally, effects of scour on modal properties of the bridge are also discussed.

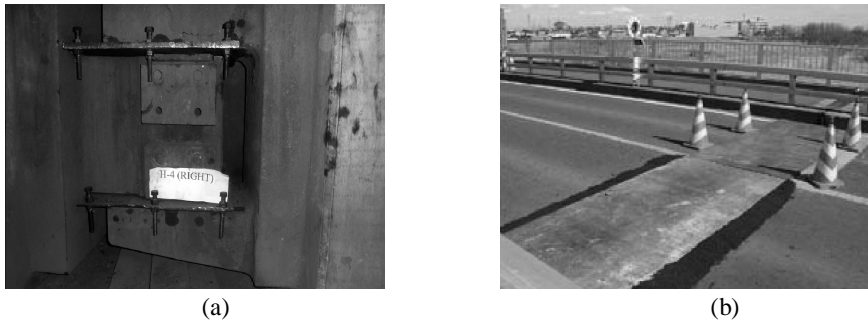
Central hinge are used to connect the deck section of each main span at mid-span location to ensure the movement of the deck ends at each side in unison. The purpose of the central hinge is to transfer the vertical load to the adjacent span when the vehicle is near or at the edge of the cantilever. Horizontal movement was designed to be free as the male and female parts of the joints can slide freely over the stainless steel surfaces. The top surface of the deck was filled with rubber expansion joints at hinge locations. After 22 years of service, the connections at the hinge locations were not functioning properly. The expansion joints were torn and non-functioning due to the non-functional hinge joints (Figure 1a, b). The pot bearings at the hinge joints failed and many of them got lost from their original positions (Figure 1c). The rubbers confined within the pot bearings were either damaged or melted due to ageing, wear and tear. Before starting the temporary repairing work steel plates were inserted at the hinge locations as a short term repair and, at temporary repairing stage, the damaged pot bearings were replaced by rubber bearings to reduce vibration coming from non-functional hinges (Figure 3a). Expansion joints at the deck levels were covered by steel plates and bituminous wearing course were applied on both sides of the steel plate to ensure better riding corridor for traffic movements (Figure 3b).

Figure 3. Repairing work of Meghna Bridge (a) steel plates were inserted at hinge location as a short term repair, (b) expansion joints were covered by steel plates at temporary repairing stage.

tions because the insertion of improperly designed steel plates on the expansion joints. The nuts and bolts of the joints of placed steel plates were over-stressed and failed at several times when vehicles passed over the expansion joints. However, the transfer of the vertical load to the adjacent spans worked at a certain degree because of the replacement of damaged pot bearings by rubber bearings. This may be considered as an improvement in the integrity of the whole structure, after temporary repairing.
