# Work methodology for replacement of expansion joints of Meghna bridge in 2008

M. Sanaul Haque, Md. Abdus Sabur & Mofazzal Haider  
*Roads and Highway Department, Dhaka, Bangladesh*

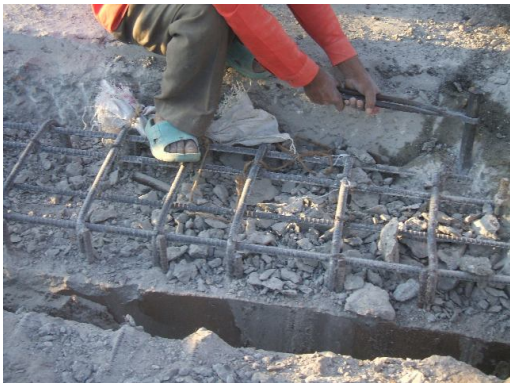
c) Chipping of concrete

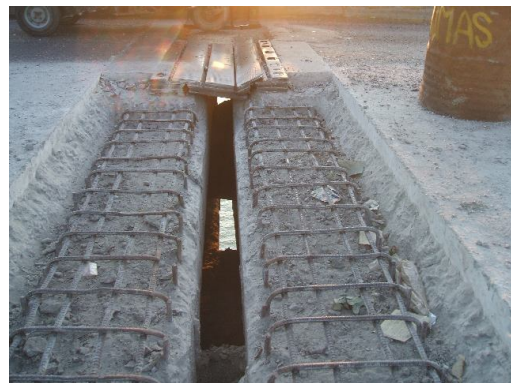
d) after chipping

When the chipping of concrete was completed, the areas of expansion joints were cleaned. Corrosion and dent at corners of reinforcing bars were observed. After removing of expansion joints damage of its material and fracture of concrete at the edge of deck slab was found. The fractures of concrete have made the gap of expansion joints wider and compelled the expansion joints to drop/sunk. Lengthwise and crosswise additional reinforcement bars were added in the bed of expansion joints to avoid reoccurrence of cracks at the edges of deck slab. Different angle bar templates were made to place different sizes of expansion joints and anchor bolts in accurate positions.

Measurements were made carefully, so that expansion joints could be placed safely and accurately. Measurements were calculated keeping temperature factor in mind. All the additional reinforcements, placing of templates & shuttering form work and fixing of bolts were done by welding. All necessary welding of reinforcement and placing of bolts were completed within three days. Cutting & chipping of concrete and placing of additional reinforcement were done simultaneously by six group of worker. This part of job was done within four day time. After placement of additional reinforcement shuttering work were done by the help of wood and polythene. Polystyrene foam wrapped with polythene sheet was used in the gap of expansion joints. After the shuttering work, casting area was covered with polythene sheets to keep it clean. Photographs of expansion joint placement are shown in Figure 6.

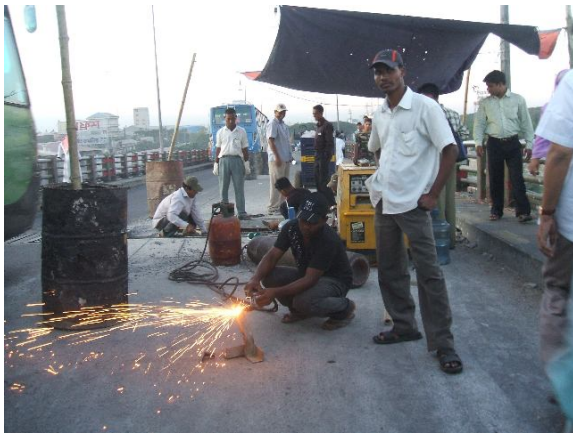
a) Welding

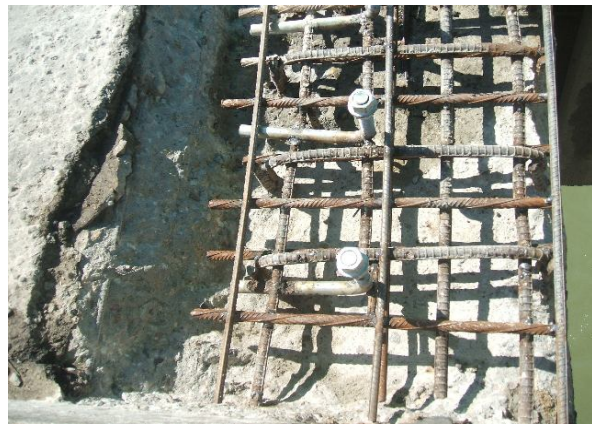
b) Additional bar reinforcement

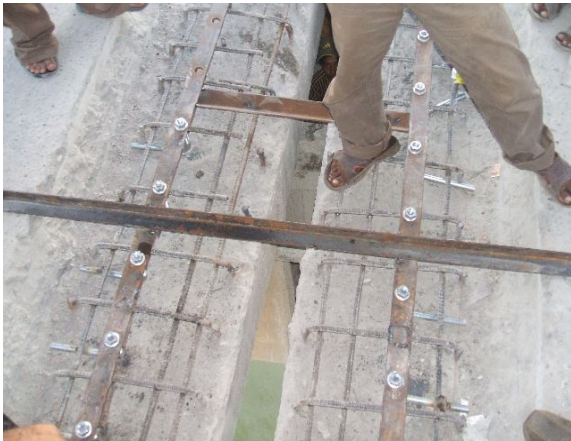
c) Setting of anchor bolts/templates

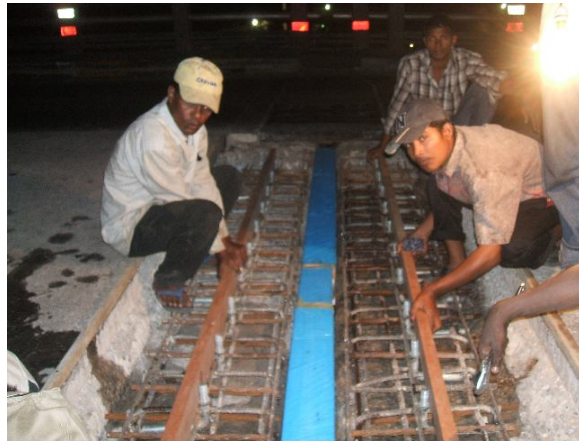
d) Shuttering work

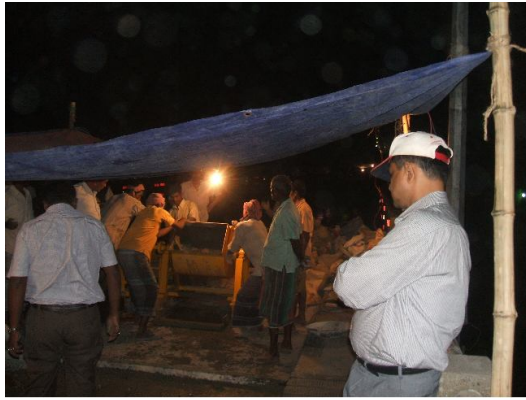
a) Concrete casting

To reduce initial and final setting time of cement and to acquire sufficient permissible strength of concrete for vehicles passing, admixture (Super Plasticizer Scancem SP1B-1.5% of cement) was used. The mix ratio of Cement: Sand: Stone Aggregates (12mm downgraded) was 1: 1.20: 2.40 and water cement ratio was 35%. After completion of concrete casting, curing was done all day long and continues for three days. Concrete surface level was adjusted to road surface level by grinding and strength of concrete was measured by Schmidt hammer. The concrete strength was greater than 2000 psi after 12 hours. The strength of concrete was good enough to withstand vibration. At 12.00 am on the next day, the lane of bridge was open for traffic where concrete was not cast. After 48 and 72 hours the concrete strength at surface level was 4000 to 4200 psi and 4500 to 5000 psi respectively. Photographs of concrete casting, curing and strength tests are shown in Figure 7.

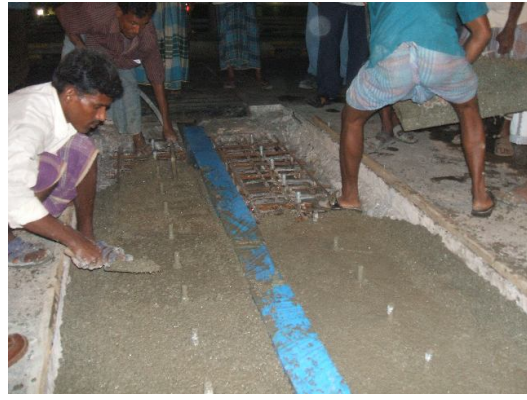
b) Curing

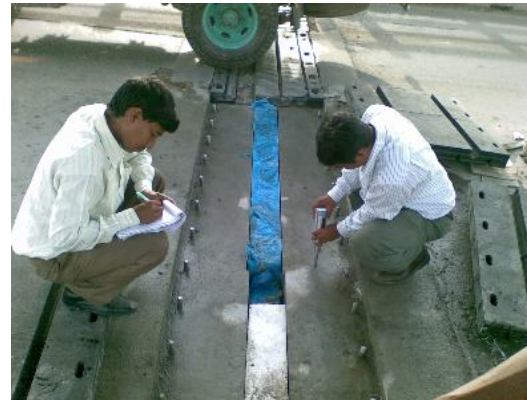
c) Strength test

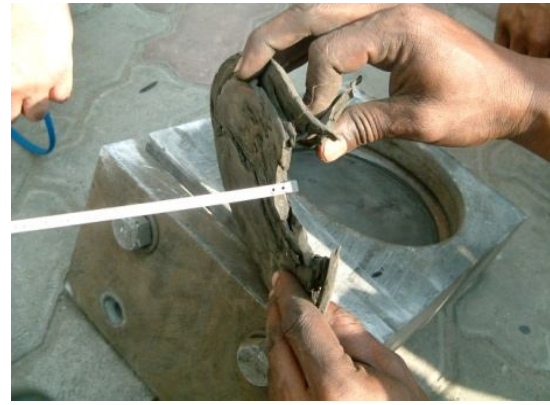
Damaged Hinge bearing

During the replacement of expansion joints additional steel plates were inserted between the gaps of damaged male and female central hinges to minimize excess movement of expansion joints. However, it is still uncertain at what interval the replacement of central hinge bearings is to be done. Photographs of central hinge and damaged hinge bearings are shown in Figure 8.

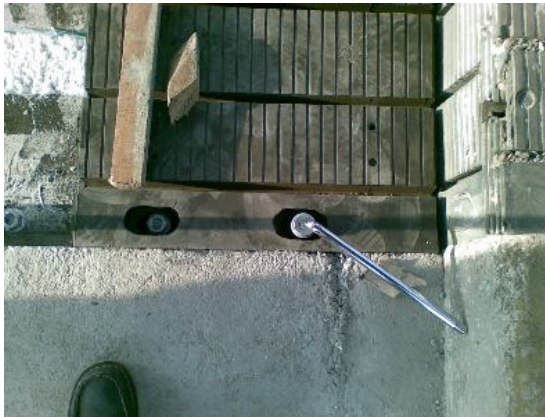
Installation of EJ & fixing of bolts

Installation of expansion rubber was started after initial setting and adjusting of concrete surface level. After placing of expansion rubber, specific sizes of bolts were used to fix the specific sizes of expansion joints. When the fixing of bolts were completed, high resilient rubber type sealant was used to resist the movement of bolts and the rubber sealant was placed over the bolts as a cap. Photographs of installation of expansion rubber are shown in Figure 9.

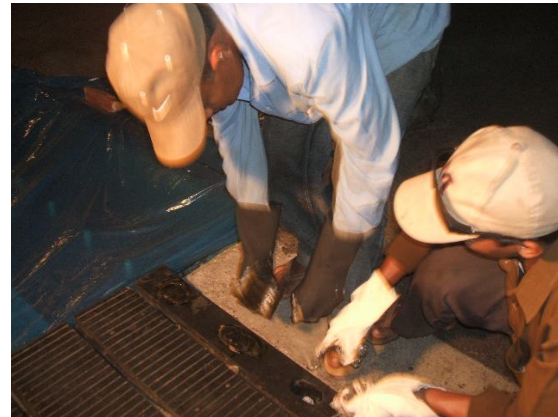
Placing of caps
