Bridge collapses around the world: Causes and mechanisms

Jamilur Reza Choudhury

Ariful Hasnat

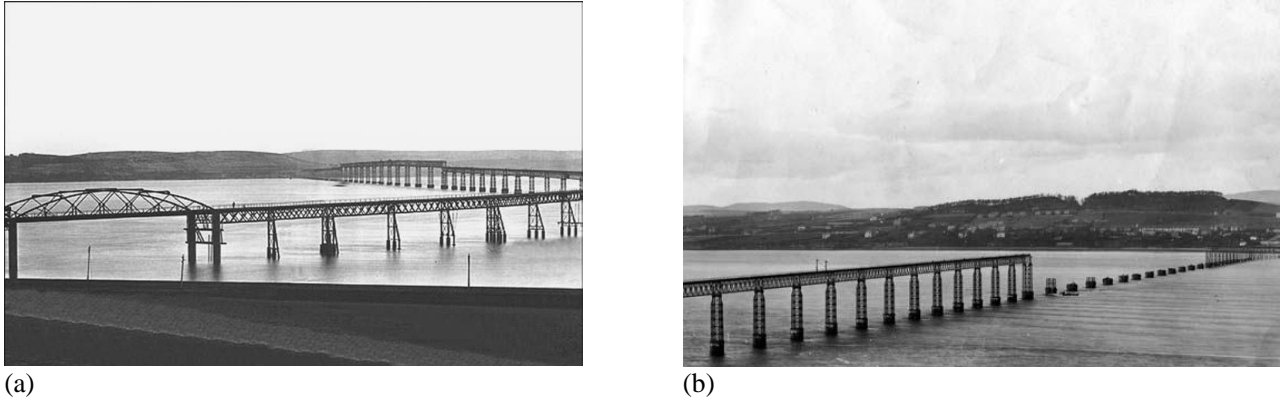
The collapse of the Tay Railway Bridge near Dundee, Scotland, on 28 December 1879, was the worst structural failure to have occurred in Britain at the time, and in terms of both lives lost and the size of the failed structure it still retains this dubious distinction. The 3.5 km long bridge was the longest railway bridge in the world at that time and it was regarded as an outstanding achievement (Figure 2a). Figure 2b demonstrates the extent of the devastation, with ten piers swept totally clear of the towers which once stood

upon them. Although wind loads contributed to the disaster, the bridge was already severely defective owing to failure of its most important stabilising elements (Lewis and Reynolds 2002).

Figure 2. Images of Tay bridge, (a) Tay bridge just after completion in 1878, (b) Collapsed high girder section of the bridge with twelve pier platforms almost completely swept off from their high girders (Lewis and Reynolds 2002).

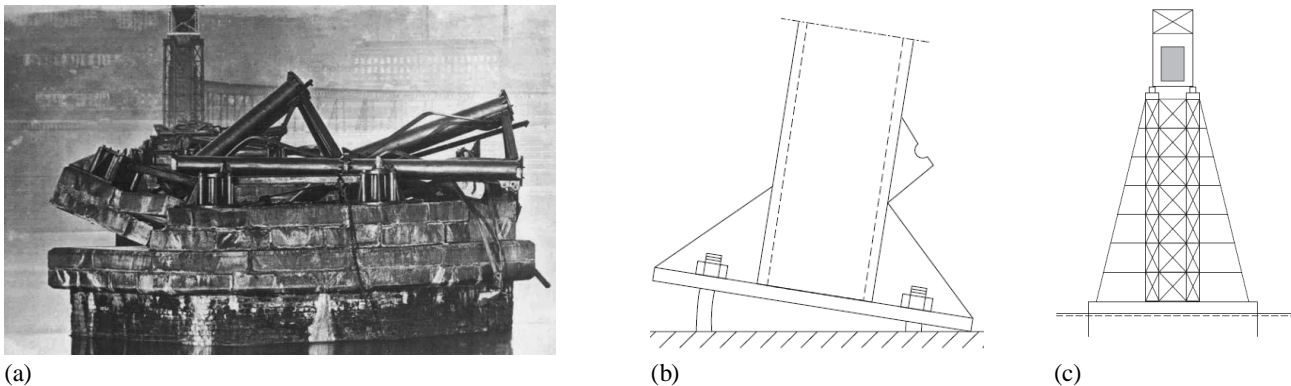
The maximum pressure came from the wind gusts, producing not only very large deflection of the truss columns in the wind direction, but also initiating resonant vibration (swaying) which amplified the forces at the base of the truss columns and the deflections of an already weakened structure, which finally became too much for the bridge to carry (Figure 3a-b). The Court of Inquiry (1879) concluded that “the fall of the bridge was occasioned by the insufficiency of the cross bracing and its fastenings to sustain the force of the gale”. The high-girder section of the bridge would definitively have benefited from an extra pair of straddling legs (like the intuitive position of a human body expecting a horizontal thrust), stabilizing the truss columns and drastically lowering the strain due to severe winds (Figure 3c).

In addition, there was also an incident during the construction of the bridge that very well could have contributed to the swaying of the bridge even during calm weather (Akeson 2008). A high girder section was damaged (slightly bent) during the lifting procedure (it was dropped into the sea), and yet this section was used. The drivers reported of a curvature in the track that produced a horizontal, transverse thrust each time the engine passed that particular section.

Figure 3. Mechanism of collapse (a) One of the broken piers of the collapsed high-girder bridge section (looking north). (<http://taybridgedisaster.co.uk/>) (b) Elongated and deformed anchorage bolt on the tension side of the cylinder base plate (Akeson 2008), (c) An extra pair of straddling legs would most probably have saved the Tay Bridge (Akeson 2008).

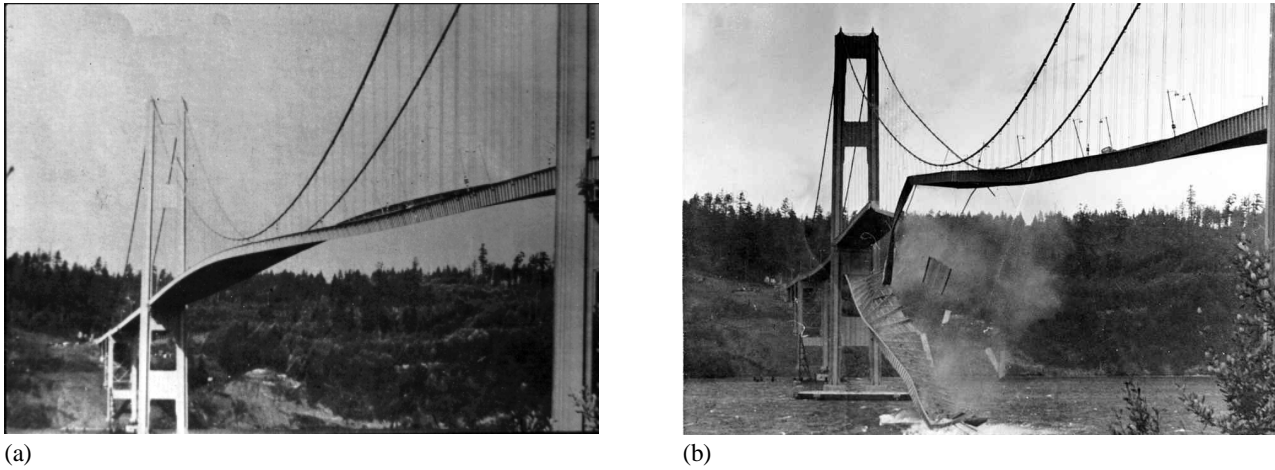
The collapse of the Tacoma Narrows Bridge near Seattle, USA, is perhaps the best recorded and documented bridge failure in bridge engineering history – the spectacular and prolonged failure process was captured on extensive live footage, giving a unique document for the investigation committee as well as for the engineering society at large. The footage has since then been used in civil engineering classes all around the world for educational purposes, and it is a very instructive video showing the consequences of neglecting dynamic forces in the design and construction of suspension bridges. On 7 November 1940, with a wind velocity of about 60 kph, the bridge began twisting and oscillating violently (Figure 4a). The bridge was twisting about 45 degrees in two waves, and oscillating up and down one meter in nine waves. The

oscillations reached 8 meters as the bridge tore itself apart (Figure 4b) (Levy and Salvadori 1992, Feld and Carper 1997). The Federal Works Agency (FWA) investigated the collapse of the Tacoma Narrows Bridge and found that the bridge was well designed and well built. While it could safely resist all static forces, the wind caused extreme undulations which caused the bridge's failure.

Figure 4. Tacoma Narrows Bridge, (a) The deflected side span on the east side, at the time of the collapse of the main span., (b) The first part of the collapse, where 183 meters of the main span tore away from the vertical hangers (suspenders) and fell into the waters below (University of Washington Libraries, Special Collections, UW 21422).

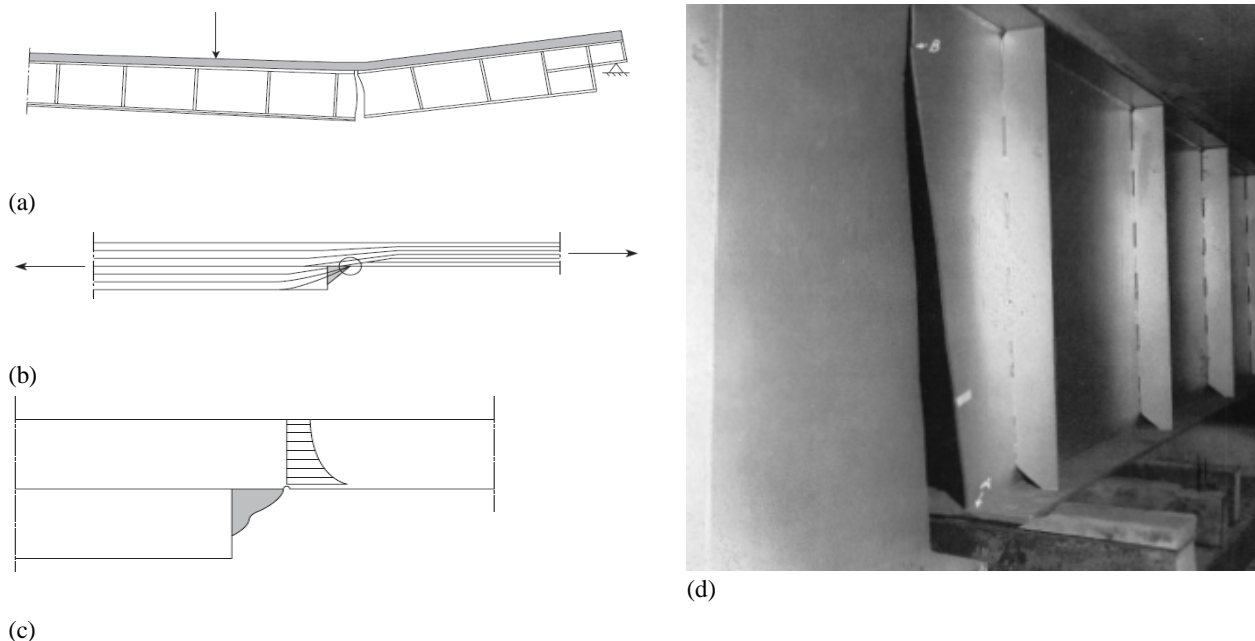
Kings Bridge in Melbourne, Australia, crosses over the Yarra River as well as over a railway and a couple of streets, in a north-southerly direction. Due to poor soil conditions it was decided to use high-strength steel in order to keep the self-weight of the I-girder bridge down. Fifteen months after opening of the bridge, on 10 July 1962, at 11 o'clock on a cold winter morning, as a 45-ton heavy vehicle was passing over the second span on the western carriageway – having approached the bridge from the south – this span broke and collapsed. It was concluded that the primary brittle fractures in these girders were due to the brittle nature of the steel. They were ‘triggered’ by the cracks present at the toes of the transverse weld at the cover plate ends (Figure 5a-d) (Akesson 2008).

Figure 5. Kings Bridge (a) Fracture in girder in southern end , (b) The stress concentration effect at the weld toe, (c) Additional stress-raising effects from the roughness of the surface, and, especially, melting ditches, (d) Complete fracture of I-girder No. 1 on the western carriageway. The photo was taken inside the bridge looking north, in between girders No. 1 and 2 (Image taken from Akesson 2008)

The faulty design of the Kings Bridge was “as if all the lessons learnt from the failures of the welded bridges in Germany and Belgium in the late 1930’s were completely forgotten - (cf. Hasselt Bridge collapse 1938)”. In fact, the bridge at Rüdersdorf also failed due to transverse welding in a tension flange, so the mistake was here repeated.

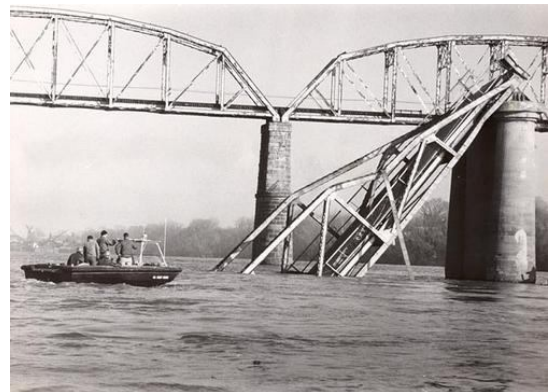
On May 13, 1926, the 69th Congress of the United States enacted legislation (later amended December 23, 1926 and May 2, 1927) granting consent to the Gallia County Ohio River Bridge Company to construct a bridge across the Ohio River. The bridge was constructed in 1927-28 as a private venture by the West Virginia-Ohio River Bridge Corporation (Figure 7a). The eastern end of the bridge was situated at Sixth and Main Streets in Point Pleasant, W.Va., and the western end of the bridge connected with Ohio State Route 7, approximately 7 km north of Gallipolis, Ohio. After some 40 years of service, the bridge collapsed without warning on December 15, 1967 during the evening rush hour, when the bridge was crowded with heavy traffic. The collapse resulted in the loss of 46 lives and nine injuries (Figure 7b). A thorough investigation revealed that the collapse of the bridge was caused by the failure of the north eyebar of the north chain at the first panel point west of the Ohio tower. The eyebar had developed a cleavage failure at the lower position of its head. The tragedy of this bridge failure led to the approval of the 1968 National Bridge Inspection Standards by the U.S. Congress.

Figure 6. Image of Silver Bridge, (a) View of Silver bridge before failure took place ([http://wikipedia.org/wiki/Silver Bridge](http://wikipedia.org/wiki/Silver_Bridge)), (b) Image taken during rescue operation after failure of bridge ([http://failures.wikispaces.com/Silver+Bridge+\(Point+Pleasant\)+Collapse](http://failures.wikispaces.com/Silver+Bridge+(Point+Pleasant)+Collapse)).

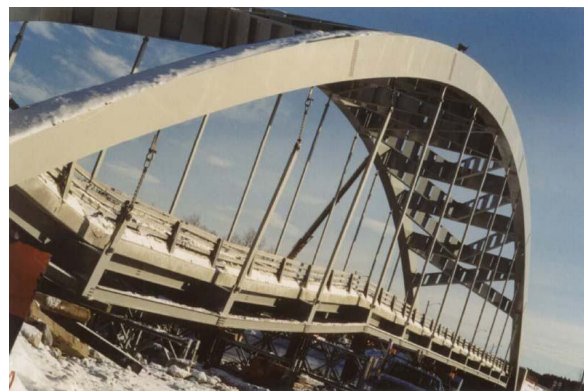
In the small Canadian town of Latchford, in the province of Ontario, a 106.7m long suspended-deck steel arch bridge spanning the Montreal River was built in October 1960. On 14 January 2003, partial failure occurred under load of transport truck during severely cold temperatures. Fatigue fractures of three steel hanger rods cited to be primary reason for failure.

Figure 7. Image of bridge (a) The Sgt. Aubrey Cosens VC Memorial Bridge, (b) Image of Bridge after failure took place. The three fractured hangers were still standing up after the collapse (Image taken from <http://www.thekingshighway.ca/latchford.html>).

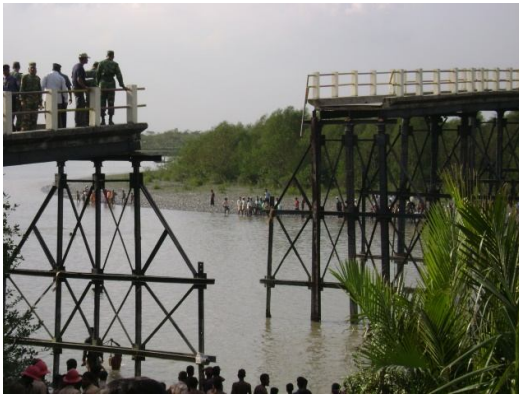
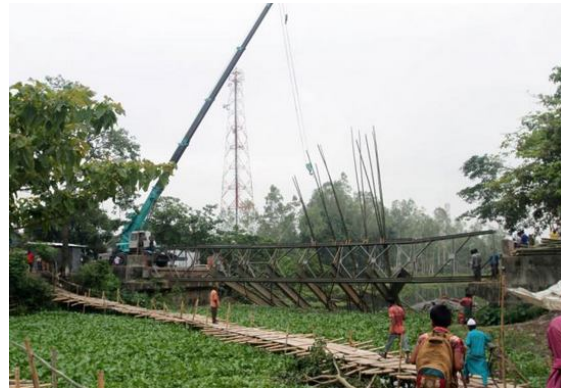
In 1960, a RC deck girder bridge near Amin Bazar, Dhaka, failed due to poor detailing of deep girders making it difficult to compact the concrete, as a result of which the girder developed wide cracks at the bottom. Flood water washed away the caissons of Noyarhat Bridge near Dhaka during construction in the 1960s. After the attack of the severe Category V Cyclone Sidr on November 15, 2007, while people were waiting on a bridge in Kalapara, a village in the Patuakhali district, for relief materials to arrive, the bridge suddenly collapsed and killed four people and hundreds were injured (Figure 8a). Failure occurred on May 28, 2015 due to heavy loading in a Bailey Bridge over the Ichamoti River at Ambari, cutting off the road link in Dinajpur (Figure 8b) (UNB 2015). A local daily newspaper reported the most recent collapse where two tankers of an oil train submerged in water due to the failure of a rail bridge at Benguira in Boalkhali upazila, Chittagong (The Financial Express, 19th June 2015). The following section presents a summary of causes and mechanisms of failure of some bridges in Bangladesh.

Figure 8. Image of bridge after the collapse (a) image of the collapsed bridge at Kalapara, (b) Image of collapsed bridge at Ambari (Photo taken from Daily Star May 28, 2015) .

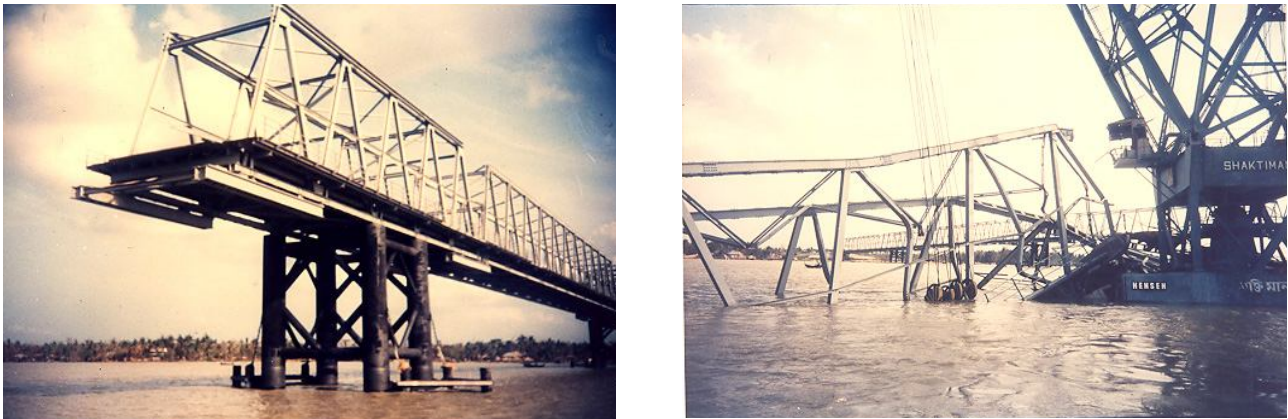
The 920 m long road bridge over river Karnaphuli, using previously used steel trusses donated by the Dutch government, was constructed during 1988-89. Just after two years of opening, on the night following 29th April, 1991, at around 3:05 am, a Category V super cyclone hit the coastal areas of Bangladesh with wind speed up to 225 kmph accompanied with storm surges up to 6m high. A 100-ton floating crane Shaktiman, which was anchored at the Chittagong port, was uprooted, moved a few kilometers upstream with the surge water and hit one of the suspended spans, removing the 100 m long steel trusses from their bearings (Figure 9a). The two trusses along with the timber decking were laid in river together with the sunken crane as shown

in Figure 9(b). Some of the piles and members of the trusses also sustained minor damages (IEB Task Force Report 1991). The following year, the damaged parts of the bridge trusses were repaired, replaced and reconstructed.

(a) (b)
 Figure 9. Image of bridge after the collapse (a) Part of Karnaphuli bridge (looking towards south), (b) Image of collapsed span along with the crane that hit the bridge. The undamaged part of the bridge is visible in the back.

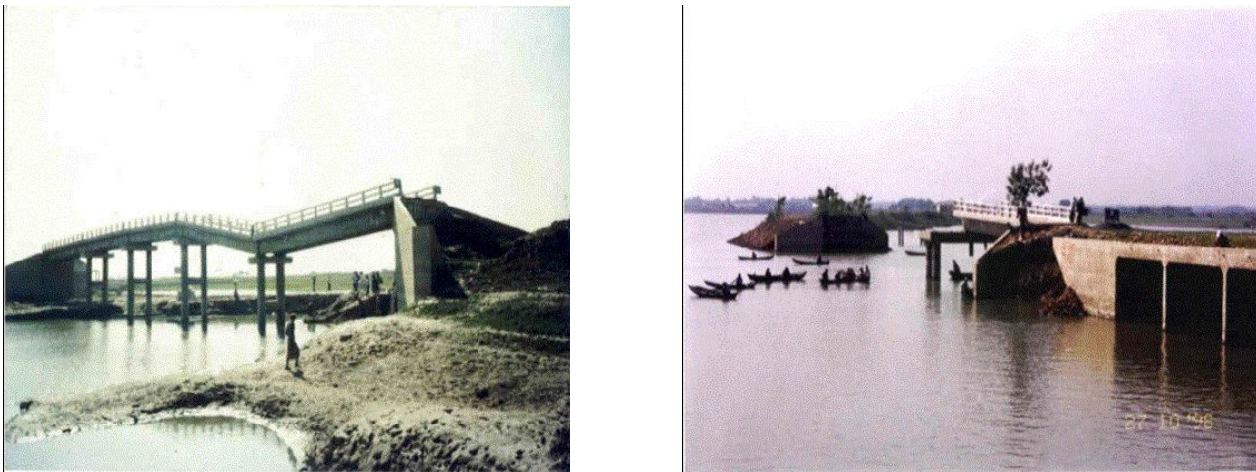
The 67 m long Turag-Bhakurta Bridge was constructed by Local Government Engineering Department (LGED) in 1995. Just after completion of its construction work, the bridge experienced a flood in 1995 and as a result, the scour depth at pier-1 reached the pile length (6 m) which led to the settlement of the pier along with the adjacent deck and girder (Figure 10a). In 1998, the flood level reached the superstructure of the bridge level and created huge hydraulic pressure on the superstructure as well as substructure (Bala et al. 2005). Due to inadequacy of freeboard some of the girders were washed away with the water due to narrow flood water path as shown in Figure 10(b) (Bala et al. 2005).

(a) (b)
 Figure 10. Failure of bridge near Amin Bazar (a) settlement of pier due to scour in 1995 flood, (b) complete collapse of bridge in 1998 flood (Bala et al. 2005)
