# Study on corrosion distribution and ultimate strength of a plate girder bridge's support area

S. Matsumoto, M. Kurihara, K. Nogami & Y. Kishi Tokyo Metropolitan University, 1-1 Minami-Osawa, Hachioji-shi, Tokyo, Japan

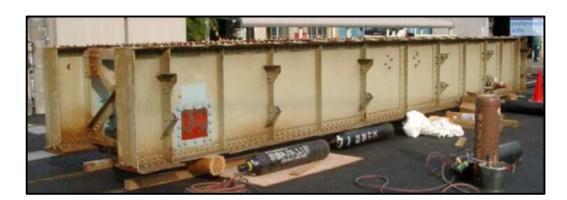
Specimen focused on this research is collected from an I-beam steel plate girder bridge called Kanasugi Bridge, shown in Figure 1. Kanasugi Bridge is a single span bridge with 2 main girders of a 9.4 meter length which was placed in Minato-District, Tokyo, Japan. The bridge was removed after approximately 90 years in service due to change in train route. The bridge's designed load is Cooper's E45 which is based on Cooper's loading system. Main girders of the bridge are assembled by rivet joint, and are consisted of web plate, angle plate, cover plate, and sole plate. Since information about the steel used for this bridge was lost, this research has conducted tensile test and chemical analysis. As the result of the tests, steel used for Kanasugi Bridge sa-tisfied standards for SS400 steel plate defined in Japanese Industrial Standard.

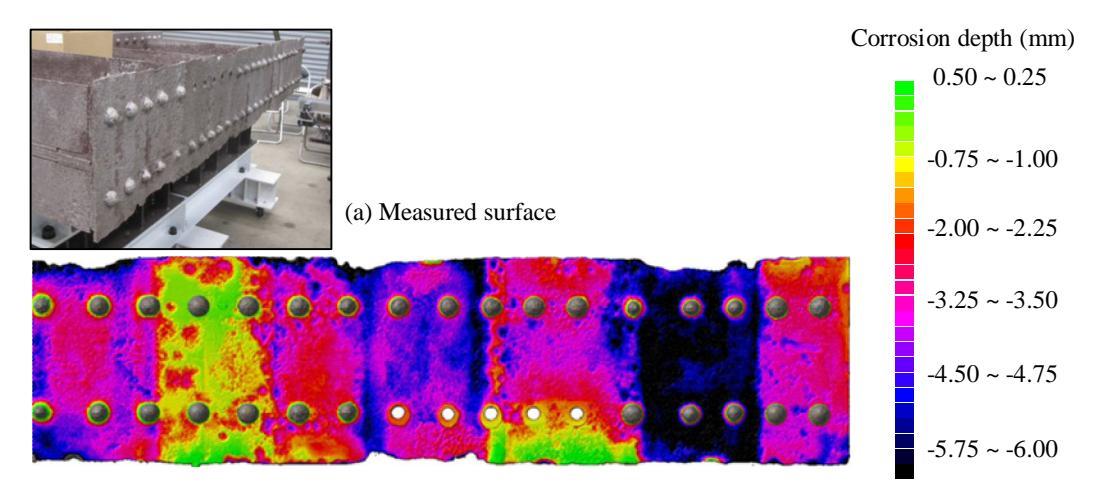
Figure 4. Corrosion depth contour figure on outer surface of upper flange

Measurement results showed tendency of the measured value to be inverted on the two sides of the specimen which indicates the effect of initial imperfection of the web plate. The maximum amount of out-of-plane initial imperfection is approximately 3.5mm. Corrosion is not apparent on the web plate on the whole and minor corrosion is found at limited to area near the support area around lower flange and end stiffener. (b) Upper Flange

Outer side of the upper flange has much corrosion in multiple areas. In particular, areas where wood crossties were placed had sever corrosion. Wood crossties had caused those areas to be placed under high humidity for long period of time, causing intensive advance of corrosion. As a result, wood crossties had caused multiple areas of outer side of the upper flange to reduce its thickness to half of the original. In addition, much area at the end of the upper flange is either lost or deformed.

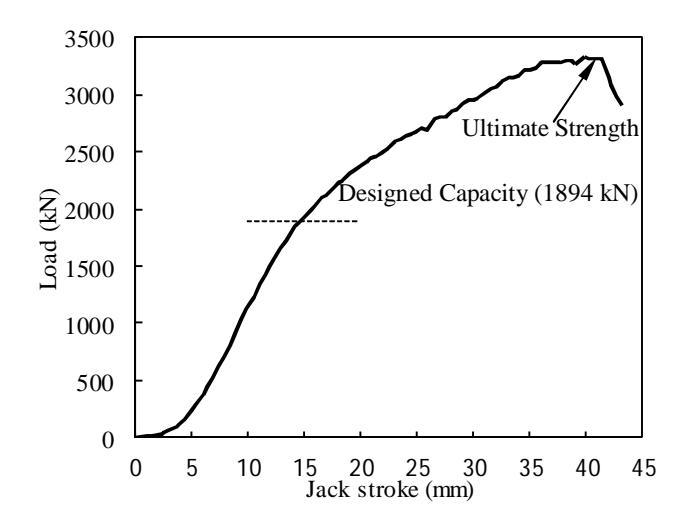
Figure 7. Load - displacement curve at loading point

As shown in Figure 7, load vs. displacement curve between the initial condition to 400 kN load is concave down which indicates the contact surface of the testing machine and the specimen are fitting together. For the loading plate was not rigid enough, it continued deforming to around 2000 kN which caused change in the boundary condition between end stiffeners from uniform distribution throughout the loading plate to concen-

trated load around the loading point. The change in the boundary condition caused the stress to concentrate on the web plate instead of flowing to end stiffeners. Local buckling was found at approximately 3290 kN on web plate around upper flange and lower flange. The form of the local buckling was sinusoidal half-waveform at both areas. Load vs. displacement curve reaches its peak at 3341 kN. After the load started to decease, the loading plate slid out because of the tilt of upper flange and the test was terminated. In Japanese standards for railway structures, compression load carrying capacity of end stiffeners at support area is calculated by adding cross-section area of end stiffeners and effective area of web plate (area of  $12 \times$  thickness of web plate) and multiplying it with allowable stress of the steel used in the structure (Railway Technical Research Institute. 2009), specified in JIS G 3101 (Japanese Industrial Standard. 2010). Designed compression load carrying capacity test revealed that the specimen possessed 1.76 times of its designed compression load carrying capacity.

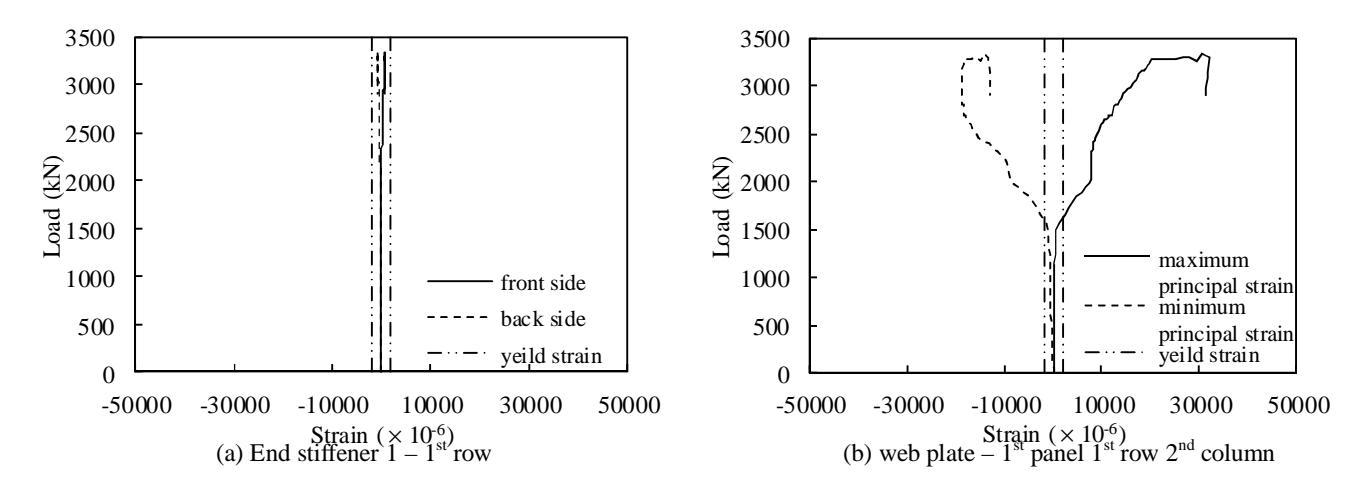
Figure 8. Load - strain curve at web plate

Strain gauges on the end stiffener recorded no yield strain at all observation points. Figure 8a shows Load vs. Strain curve at end stiffener 1 near the upper flange. Instead, strain gauges placed at area near to upper and lower flange on the 1<sup>st</sup> panel recorded strain exceeding yield strain, as shown in Figure 8b. Strain gauges on the 2<sup>nd</sup> panel did not record yield strain. 3 axis strain gauges on 2<sup>nd</sup> panel which is placed diagonally from lower flange side of inter stiffener 1 to upper flange side of inter stiffener 2 also did not record yield strain indicating that no oblique tensile force emerged.
