# Preventive maintenance on highway-railway combined bridges

M. Okawa & T. Kurihara

*Honshu-Shikoku Bridge Expressway Co. Ltd, Shimokawatsu 4388-1, Kawatsu-cho, Sakaide-shi, Kagawa, Japan*

**ABSTRACT:** Seto-Ohashi Bridge is a series of long-span bridges that locates at the center of three Honshu-Shikoku Expressways. The 9.4 km-long bridges are road-railway combined bridges and accommodates 4-lane expressway on the upper deck and 2-railway track on the lower deck. The bridges are surrounded by marine conditions and being exposed to severe weather. To ensure long service life and reduce a life cycle cost, a systematic maintenance that emphasize on preventive maintenance is conducted for the bridges. This paper describes current maintenance measures and the technologies for the preventive maintenance of Seto-Ohashi Bridges.

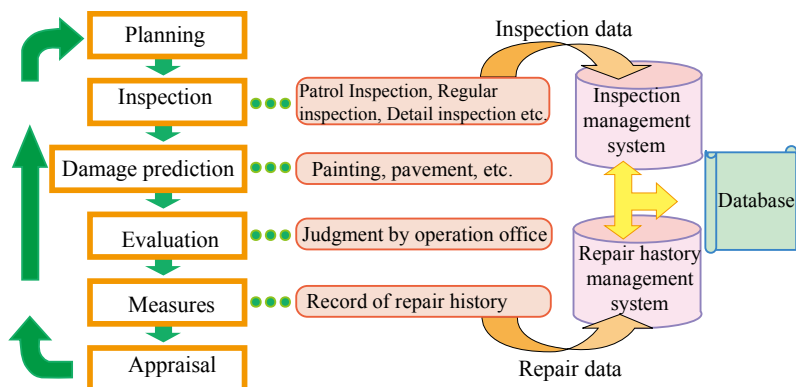
Figure 8. Cycle of “Preventive Maintenance”

A specially developed data base for HSB comprising “Inspection Management System” and “Repair History System” helps HSBE to predict development of the damages and evaluate necessity of countermeasure as shown Figure 8. The data base has functions of accumulating inspection data and recording repair history.

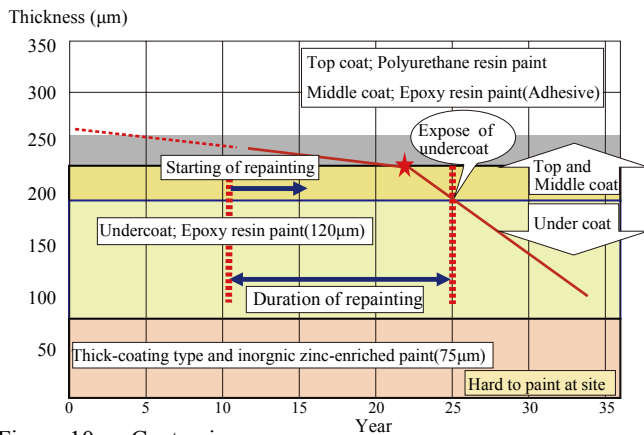
Figure 10. Coat aging curve

Condition of the coating of HSB has been monitored at fixed points set on representative bridges at regular intervals to know when to start repainting. Items to be checked at the inspection are as follows: thickness, grade of luster, adhesion. Coat thickness is a vital item in determining timing of repainting and measured with photograph of tiny paint samples taken by optical/scanning electron microscope.

Based on these results, exhaustion speed of the top coat and middle coat can be estimated and deterioration curve can be drawn. The deterioration curve shows beginning time of exhaustion of the under coat, which should be completion timing of repainting. So repainting works has to be started considered the timing and duration of repainting. Figure 11 shows repainting schedule for Seto-Ohashi Bridges. Thus repainting work started in 2006 and is scheduled to finish in 16 year.

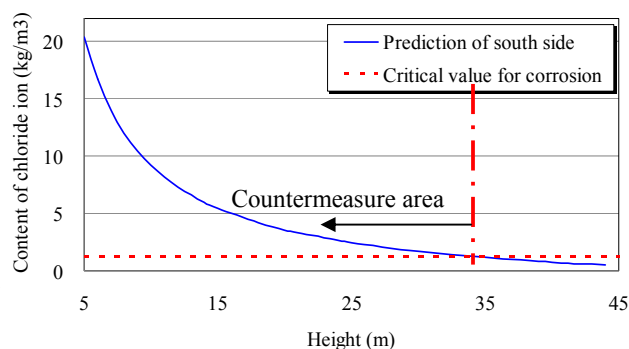
Figure 13. Prediction of chloride ion content by height

Figure 13 shows prediction of chloride ion content by height at the south side of the 7A anchorage in one hundred years after completion at depth of 100mm from surface. The result indicates that countermeasure is required in the range of 5m to 35m above sea level.

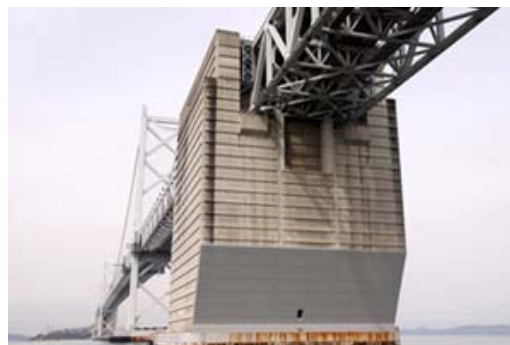
Photo 1. Anchorage of the Minami Bisan-Seto Bridge

Based on the prediction result, coating works are in progress at selected area on mass concrete structure of Seto-Ohashi Bridges to prevent chloride damage and carbonation. As for the material of coating, acrylic urethane paint is adopted. After opening of Seto-Ohashi Bridges, the study on coating system for mass concrete started, aiming at finding the most suitable material. Several materials were used for trial basis. Finally acrylic urethane was selected as it showed the best performance in following movement of concrete crack. This coating was on experiment basis at the 7A anchorage of Minami Bisan-Seto Bridge.

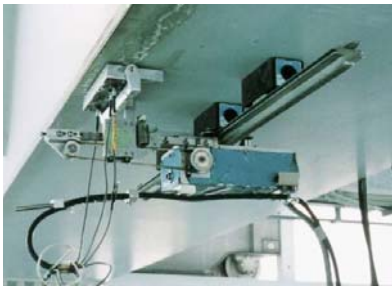
Photo 2. Automated Ultrasonic Testing system

After conducting a series of large-scale fatigue test, HSBE developed a welding methodology as well as a welding inspection system called “AUT: Automated Ultrasonic Testing system”. As the AUT was effective in detecting welding defect in the factories, HSBE made several improvements on the system before HSBE started on-site AUT inspection in 1990 so that the system can be available to existing welding lines. There was no sign of crack progress as a result of 2 times inspection conducted by 2000. It was attributed to the fact that actual load of train is smaller than the design assumption.

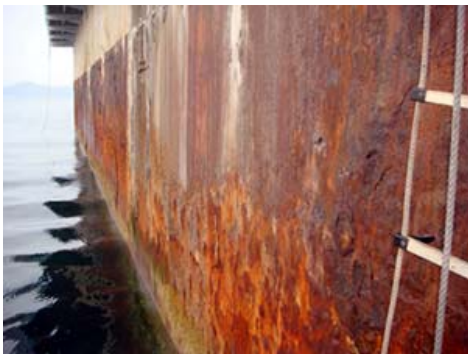
Photo 4. The current situation of the splash zone of the steel caisson

Splash and tidal zone is the most corrosive area of the steel shell. Photo 4 shows current situation of the splash zone at the 4A anchorage of Minami Bisan-Seto Bridge. The thickness of the shell at splash zone has decreased by 5mm (in average of particular area) from original thickness of 12mm. The protection work started in 2009, at the underwater foundations where the Electric Deposit Method had been completed. The coating area of slash and tidal zone is in the ranges from one meter below the sea level, which is top of the electric deposit, to the top of the steel shell.

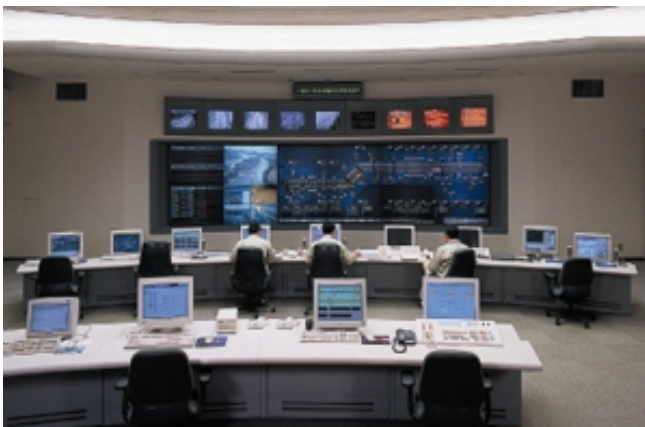
Photo 6. Graphic panel at traffic control center

In the case of the Seto-Ohashi Bridge, HSBE equipped an efficient system to collect data on traffic conditions: traffic volume, speed of traffic flow etc., and weather conditions: intensity of rainfall, wind speed & direction, range of visibility, temperature of road surface. These data are quickly analyzed and appropriate

measures are taken, by offering information to road users through the roadside LED information panels and highway broadcasting, etc.

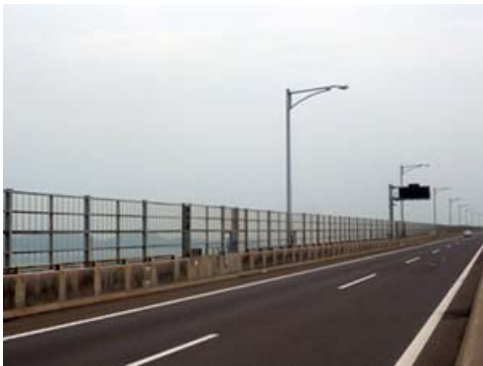
Photo 8. Windbreak fence on approach viaduct

According to that, windbreak fence was placed on the west side of the viaduct against seasonal dominant wind direction. The fence is made of polycarbonate board with 30-40% infilling ratio and 3m high. The board is transparent for a comfortable drive.
