Influence of deformation due to collision on mechanical behavior of steel bridge

E. Yamaguchi, T. Amamoto & D. Nakashima
Kyushu Institute of Technology, Kitakyushu 804-8550, Japan

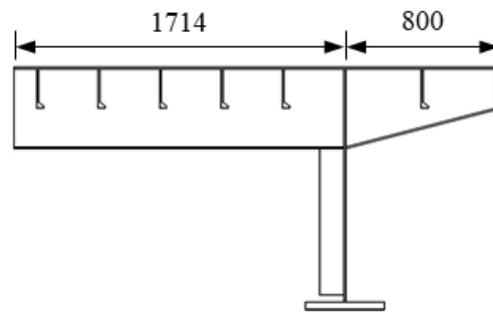
Figure 9. Cross section of girder to be analyzed.

To evaluate the influence of the damage caused by the collision, the bending capacity of the damaged girder by itself is obtained by the nonlinear finite element analysis. The girder to be analyzed here is taken out of the bridge deformed by the collision load in the previous section. The orthotropic deck of the effective width is included in this girder model (Figure 9).
