Experimental investigation on dynamic characteristics of Meghna bridge at different structural conditions

ABSTRACT: Meghna Bridge is a pre-stressed concrete box girder balanced cantilever bridge with 87 meter long spans, each with a central hinge at cantilever portion. Significant vibrations were induced by vehicles passing over the non-functioning expansion joints at central hinges caused by severe traffic loading and lack of maintenance. Emergency repairing works were done to overcome the problem. This paper describes an experimental investigation on dynamic characteristics of the bridge with different structural conditions. Vibration measurements were carried out using tri-axial sensors on bridge deck before and after temporary repairing works. Due to nonexistence of synchronization device, cross-correlation technique was applied to reduce time lags in the vibration data recorded with different measurement devices. The Eigensystem Realization Algorithm was used to analyze the vibration records. Effects of repairing on modal properties of the bridge are discussed. Additionally, effects of scour on modal properties of the bridge are also discussed.

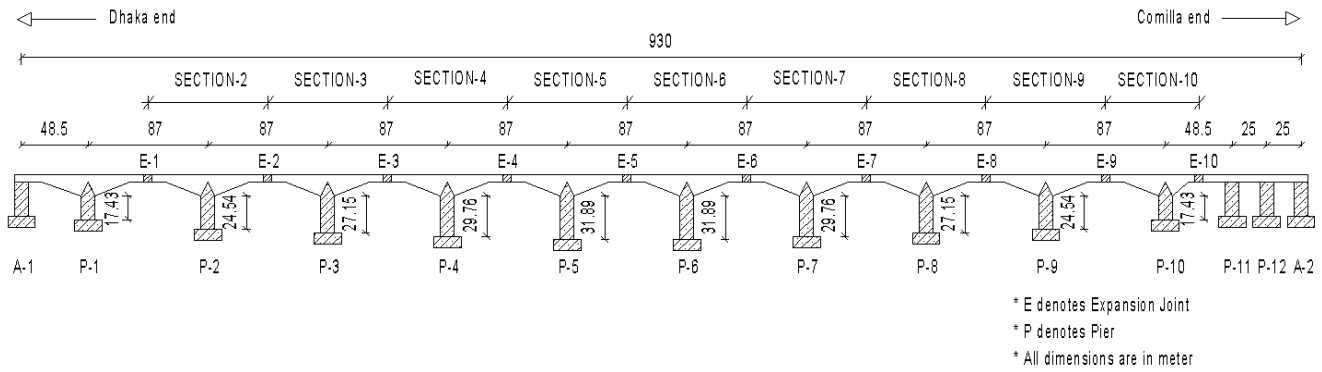
Figure 2. Schematic elevation of Meghna Bridge showing span lengths, pier heights and expansion joints.

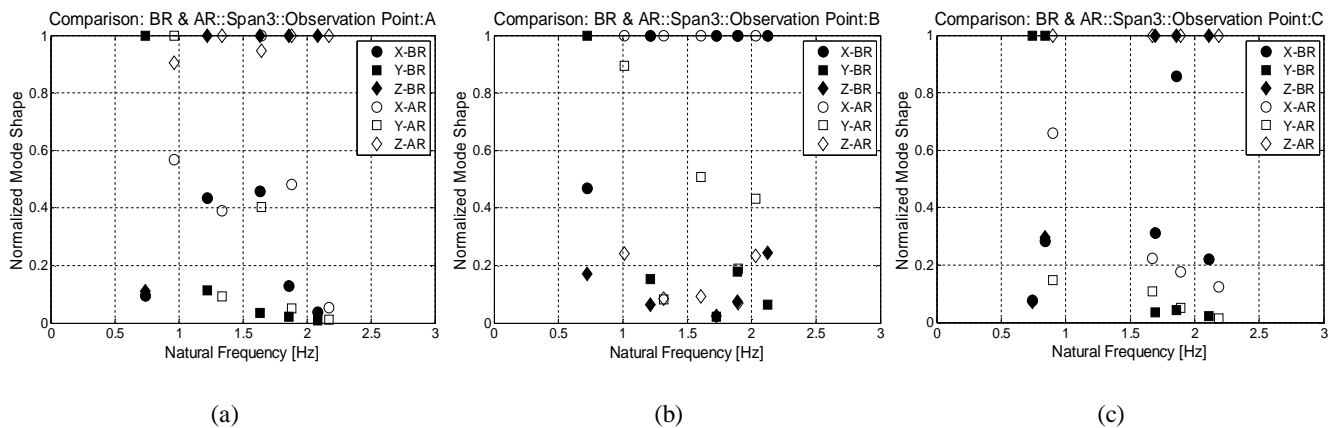
In order to understand the effect of repair on modal properties, the dynamic characteristics of the bridge identified from the recorded data were compared before and after temporary repairing work. Tables 1 and 2 summarize the natural frequencies and dominant directions of first three vibration modes of SECTION 3 and SECTION 8 attained from the data obtained at a single location before and after temporary repairing work. In the tables, the dominant directions of vibration modes were selected if the corresponding component in the modal vector normalized by its maximum component was greater than 0.9. Examples of the normalized modal vectors are shown in Figures 7 and 8. From Tables 1 and 2, it can be observed that the natural frequencies of the first three vibration modes at frequencies between 0.65 Hz and 2.25 Hz have been changed along with the dominant directions of 1st vibration mode. The mode shapes of the first three vibration modes were obtained from synchronized data, but there can be error in modal properties, particularly phases, because the process of synchronization by cross correlation technique cannot synchronize the time-history data series completely. Figure 9 shows time histories recorded by three sensors placed at three different locations. It can be observed in Figure

Figure 7. Natural frequencies, normalized mode shapes and dominant directions of some principle vibration modes of SECTION 3 at (a) Observation point A, (b) Observation point B, and (c) Observation point C.

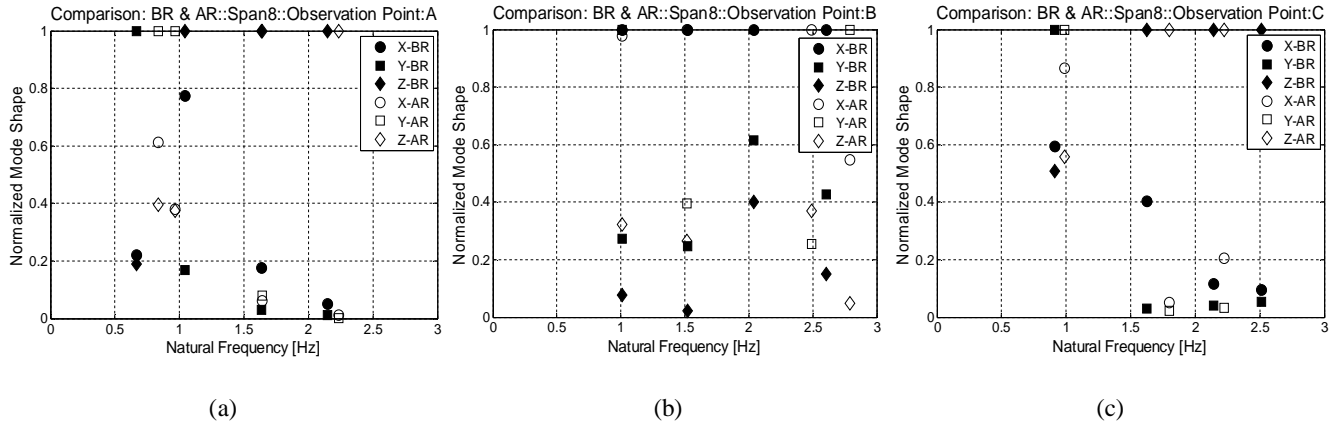
Mode number	Observation point : A				Observation point : B				Observation point : C			
	Natural frequency (Hz)		Dominant direction		Natural frequency (Hz)		Dominant direction		Natural frequency (Hz)		Dominant direction	
	BR	AR	BR	AR	BR	AR	BR	AR	BR	AR	BR	AR
1st mode	0.668	0.834	Y	Y	0.685	1.011	Y	Y	0.914	0.989	Y	Y
2nd mode	1.638	1.642	Z	Z	1.522	1.519	X	X	1.626	1.798	Z	Z
3rd mode	2.148	2.235	Z	Z	2.040	2.489	X	X	2.140	2.225	Z	Z

Figure 8. Natural frequencies, normalized mode shapes and dominant directions of some principle vibration modes of SECTION 8 at (a) Observation point A, (b) Observation point B, and (c) Observation point C.

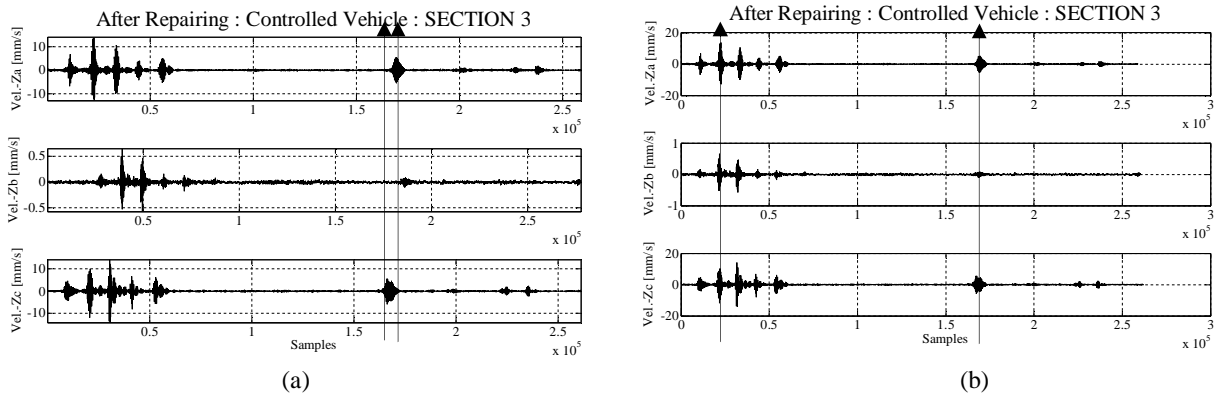
9 that before synchronization there were time lags among the sensors but after synchronization there was no obvious time lag. The peaks of all three time histories are indicated through an arrow line. However, the reduction of time lags does not mean the data have been synchronized and, therefore, vibration mode shapes obtained from the synchronized data summarized in Table 3 can be erroneous. It can be observed from Table 3 that the 1st vibration mode shape after temporary repairing work seems to be different from the mode shape before repairing but the other two vibration modes have not been affected significantly by repairing works. This could be happened because, after temporary repairing, the dominant direction of that particular mode has been changed to longitudinal and vertical direction (Table 1). Because the insertion of steel plates on the expansion joints were not properly designed considering the horizontal movement of the bridge, it was confirmed that, when vehicle passed over the expansion joints, the nuts and bolts of the joints of placed steel plates were over-stressed and failed at several times. However, due to the replacement of damaged pot bearings by rubber bearings, the transfer of the vertical load to the adjacent spans worked at a certain degree. Therefore, it can be concluded from the above explanation that, after temporary repairing, the integrity of the whole structure have been increased at a certain degree due to the replacement of damaged pot bearings by rubber bearings at central hinges.

Figure 9. Example time histories of three sensors placed at three different locations (a) before synchronization and (b) after synchronization.
