# Work methodology for replacement of expansion joints of Meghna bridge in 2008

M. Sanaul Haque, Md. Abdus Sabur & Mofazzal Haider  
*Roads and Highway Department, Dhaka, Bangladesh*

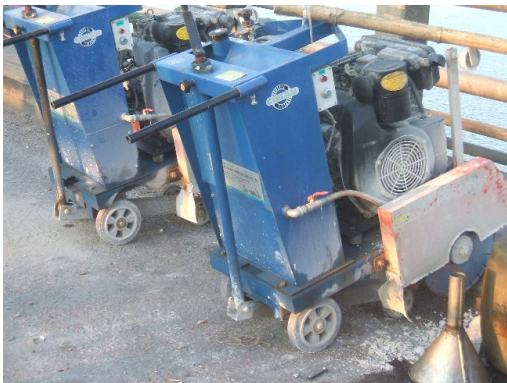
a) Concrete Cutter

Concrete surface was cut and damaged expansion joints were removed. At first the measurements for cutting and breaking of concrete were made. Concrete was cut by a mechanical cutter and damaged expansion joints were removed by breaking of concrete by the help of chisel and hammer. It required 30 minutes for concrete cutting and approximately 6 hours for breaking of concrete at each expansion joint. Six groups of worker were engaged for mechanical cutting and manual breaking of concrete. Within two days time, breaking of all the 13 joints were completed (half width). Photographs of concrete cutter, concrete cutting and chipping are shown in Figure 5.

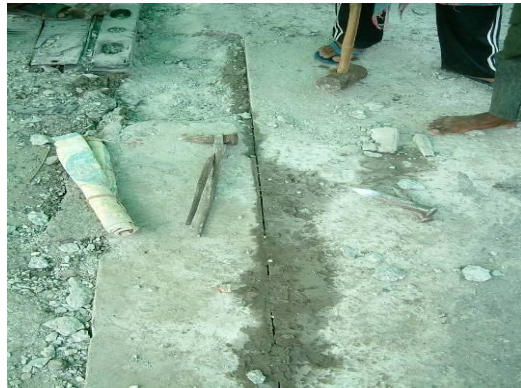
b) After cutting
