Bridge collapses around the world: Causes and mechanisms

Jamilur Reza Choudhury

Ariful Hasnat

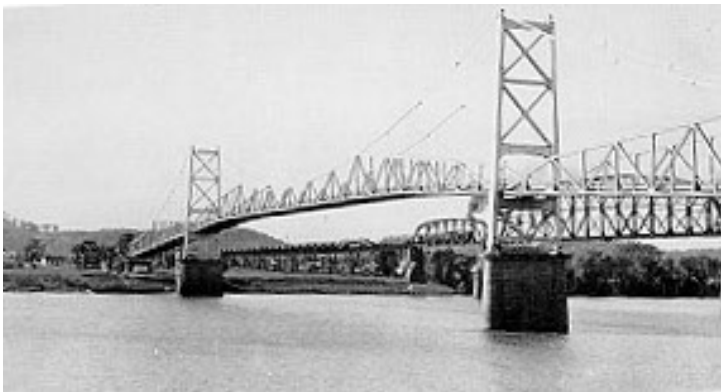
(a)

On May 13, 1926, the 69th Congress of the United States enacted legislation (later amended December 23, 1926 and May 2, 1927) granting consent to the Gallia County Ohio River Bridge Company to construct a bridge across the Ohio River. The bridge was constructed in 1927-28 as a private venture by the West Virginia-Ohio River Bridge Corporation (Figure 7a). The eastern end of the bridge was situated at Sixth and Main Streets in Point Pleasant, W.Va., and the western end of the bridge connected with Ohio State Route 7, approximately 7 km north of Gallipolis, Ohio. After some 40 years of service, the bridge collapsed without warning on December 15, 1967 during the evening rush hour, when the bridge was crowded with heavy traffic. The collapse resulted in the loss of 46 lives and nine injuries (Figure 7b). A thorough investigation revealed that the collapse of the bridge was caused by the failure of the north eyebar of the north chain at the first panel point west of the Ohio tower. The eyebar had developed a cleavage failure at the lower position of its head. The tragedy of this bridge failure led to the approval of the 1968 National Bridge Inspection Standards by the U.S. Congress.

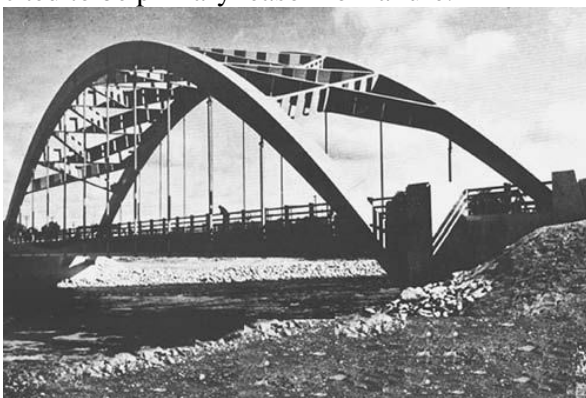
(a)

In the small Canadian town of Latchford, in the province of Ontario, a 106.7m long suspended-deck steel arch bridge spanning the Montreal River was built in October 1960. On 14 January 2003, partial failure occurred under load of transport truck during severely cold temperatures. Fatigue fractures of three steel hanger rods cited to be primary reason for failure.
