A field investigation of vibration-based structural health monitoring in a steel truss bridge

ABSTRACT: This paper presents an investigation to seek the applicability of vibration-based technique to structural health monitoring of steel truss bridges. A Warren truss bridge for road traffic in-service for more than 40 years was used in this investigation. There were a partial fracture, cracks and pitting corrossions in diagonal members of the truss bridge detected during recent visual inspections and some of those damages were repaired during the investigation. Vibration measurements were conducted for the identification of global vibration mode of a single span and local vibration modes dominated by vibration of diagonal members. Road traffic was the source of vibration during the measurements. Impact testing was also conducted for the measurement of local vibration. The possibilities of modal properties of global and local vibration modes in the identification of structural changes in truss bridges were discussed based on the results of measurement and finite element analysis.

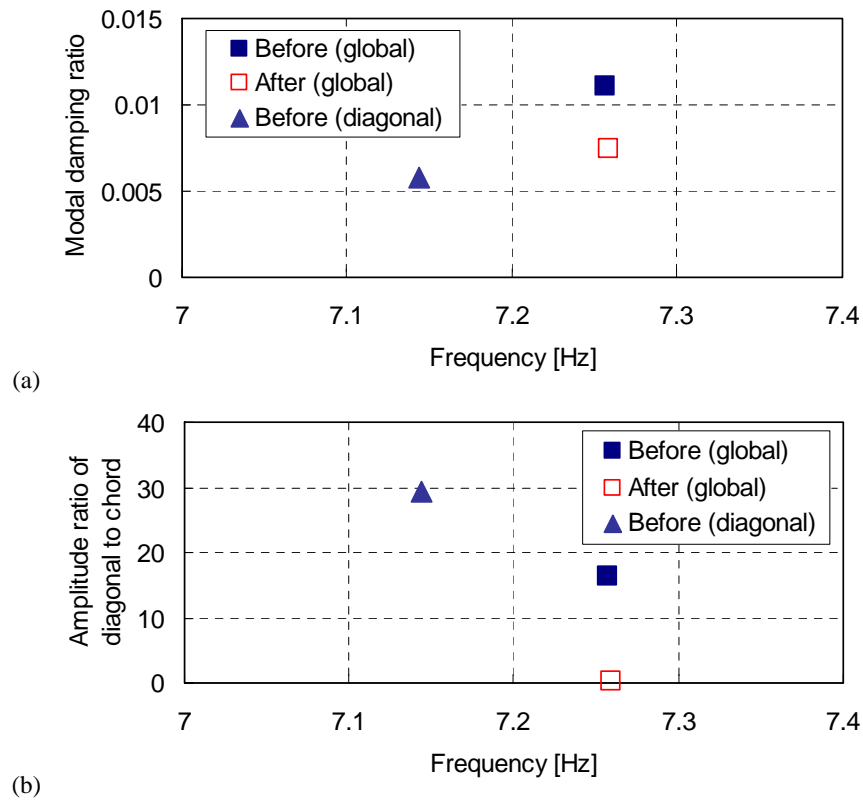
Figure 7. Relation between changes in modal damping ratio and dynamic coupling between diagonal and lower chord members. (a) modal damping ratios and (b) amplitude ratios of diagonal member to lower chord member in local and global vibration modes before and after reinforcement.

Figure 7 shows the relation between the changes in modal damping ratio found in the vibration mode at 7.26 Hz, as shown in Figure 6, and the dynamic coupling between the diagonal and lower chord members. The dynamic coupling between the diagonal and lower chord members are represented by the ratio of the modal amplitude of the diagonal member to the modal amplitude of the lower chord member in the figure. The modal amplitude of the diagonal member was obtained by subtracting the modal amplitude at the end of the diagonal member from that identified for the measurement location in the diagonal member.

The vibration mode at 7.14 Hz shown in Figure 7 was the local mode dominated by the motion of the damaged tension diagonal member D5 as indicated by a high amplitude ratio of the diagonal member to the lower chord member (i.e., about 30). As shown in Figure 6, the modal frequency of the local mode increased from

The decrease in the amplitude ratio of the diagonal member D5 to the lower chord member from about 16 to 0 in the global mode at 7.26 Hz, as shown in Figure 7, implies that there was no dynamic coupling between the diagonal member D5 and the lower chord member after the reinforcement due to the increase in the modal frequency of the local mode of D5. The decrease in the modal damping ratio of the global mode at 7.26 Hz may be associated with the loss of coupling between the diagonal and lower chord members that was caused by the change in the mechanical property of the diagonal member. This finding suggests that the modal damping ratios of global modes may be used as an indicator of local damages in diagonal members in steel truss bridges.
