# Effect of stop-hole on fatigue at vertical stiffener welds of orthotropic steel deck

K. Osumi & H. Tokida

*Highway Technology Research Center, Tokyo, Japan*

**ABSTRACT:** A lot of fatigue cracks have been observed in welded joints between steel deck plates and vertical stiffeners of orthotropic steel deck under severe traffic load. Stop-hole method for preventing the extension of fatigue cracks by drilling circular holes at the tips of the cracks is often used as a countermeasure against these fatigue cracks. However, its effect has not been so clear. In this study, for the purpose of making clear the effect of stop-hole Method against fatigue crack in welded joints between vertical stiffener and deck plate of orthotropic deck, fatigue tests and finite element stress analyses are performed on small size specimens modeling the welded joints between deck plate and vertical stiffener. In addition, fatigue strength curve is proposed for performing the fatigue durability evaluation for the portion repaired by stop-hole method.

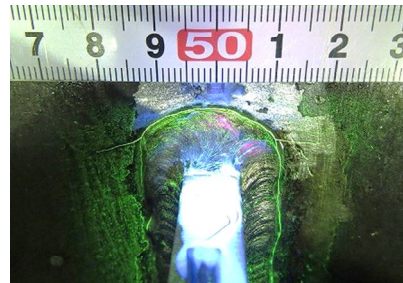
Figure 5. Before the repair (No. 3R).

The states of a fatigue crack before and after repair with a stop hole are shown in Figure 5 and 6, respectively. The position of installing two stop holes sandwiching the crack was built with the diameter of 22mm so that the interval between the outer portions of a porous wall could be 80mm and that they could be positioned symmetrically across the vertical stiffener. The chamfering of about 2 mm to the edges of stop hole was performed. In addition, the finishing of porous walls of stop holes was performed so that there were no scratches in porous walls that could occur during the preparation of stop holes and in order to surely verify situations of removing the crack tip after installing the stop holes. Their finishing was made through polishing by using a bar grinder with a vitrified grinding stone (# 36) and then with a rubber grinding stone (# 80 or 120). After the stop holes were installed, the development and recurrence of fatigue cracks were examined by measurements of strain range by using strain gauges putting on the upper and lower surfaces of the deck located 3 mm each from porous holes on the upper surface of the deck above the edge face of the vertical stiffener and on the outer part of the stop hole as shown in Figure 4. In addition, since there are four stop holes in a specimen, they are distinguished with L/R and E/W, as shown in Figure 3.
